Condition Report of the Building Services Installation.

Alice Shepherd House

Prepared by MCCE on behalf of Hunter & Partners for One Housing

February 2018

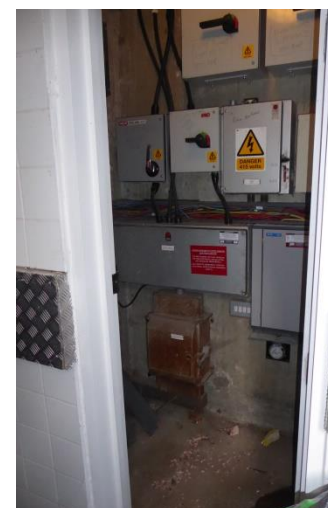
Most of the main isolators appear to have been replaced but some of these appear very dated although operational.

Oldest isolator
serving the Booster
Pump room

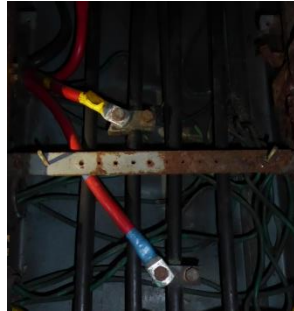
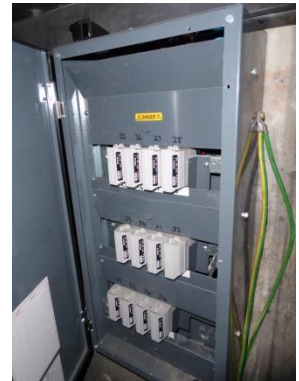
The Ryefield Boards appear to have been replaced in 2002

The rising cabling serving the Ryefield Boards appears original and very dated and some immediate H&S repairs to enclose live terminals etc. are required.

The budget allows for the replacement of the rising bus bar system and the feeds to each dwelling making allowance for the condition of the service. However, this may need to move forward due to the availability of spares.

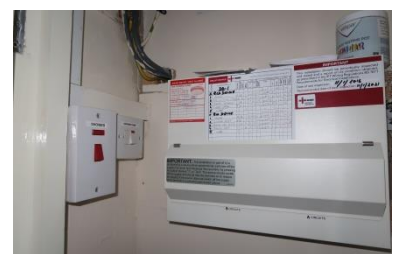
Wiring from Ryefield to Dwellings

The Ryefield boards serving the dwellings have been replaced in 2002. The wiring between the Ryefield and each dwelling was not replaced and appears to be as originally installed with the buildings construction.

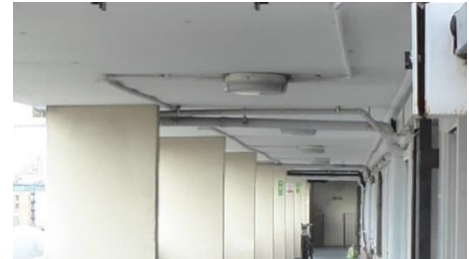
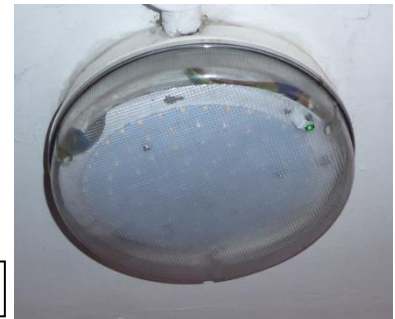
There is evidence of some of the fittings having had LED replacement plates fitted but these do not appear to fit correctly and we would recommend complete replacement of the fittings when they fail

Modified Communal Lighting

The main fittings are estimated to be approximately 10-12 years old with an anticipated life of 15 years. It was unclear from the survey if the wiring had been replaced with the fittings and so the budget below allows for a complete system replacement in year 4.

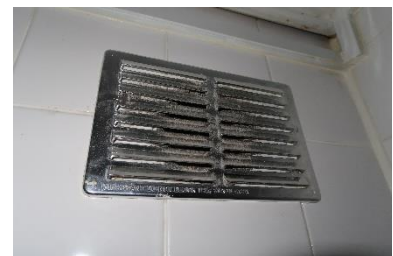
Vent in Flat 1

The fans and roof plant room ductwork system were replaced in 2010 but it is unclear if the rest of the ductwork system from the roof to the dwellings was cleaned, although from the dust build-up on the inside of the grille shown, it appears that this was not carried out.

The cleaning of the ductwork and more specifically the internal grilles is necessary for the systems operation and to reduce the risk of fire. As access is required into all dwellings, it

has been budgeted for the these works to be carried out in conjunction with the Fire Damper Installation detailed below to avoid additional costs.

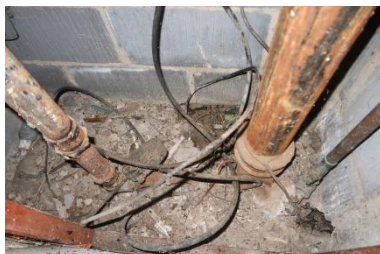
150mm CI
Soil Pipe

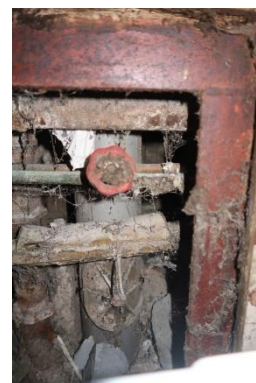
100mm CI Soil
Pipe with Water
Services

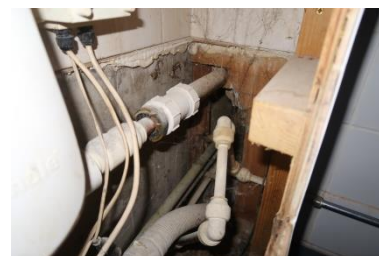
PVC WHB connection to original
Copper Waste Pipe

From the survey of the Flat No.1 and MCCEs experience within similar blocks with Cast Iron soil stacks, leakages are caused by the poor connection rather than the main soil stack failures.

The photo above shows a typical new connection leading to the stack from the WHB in the bathroom using a white compression fitting onto the original copper joining the stack. This one appears to be carried out in a reasonable fashion using a Mcalpine fitting to join the copper and is formed outside of the riser.

The works below is an allowance to enter each dwelling and replace the drainage connection to the main soil stack with a connection that is designed to be used with a Cast Iron Stack. The connection will be linked to the resident's system external to the riser allowing the resident make modifications in the future without entering the riser.

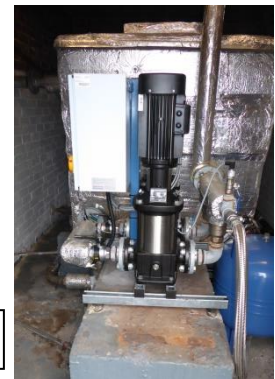
Pump set and Break Tank

The booster pump-set was also installed in 2010 but the storage tank was not replaced. The schedule of works in 2010 suggests that the rising main pipework from the booster to the roof tanks was replaced. However the down service from the roof tanks serving the dwellings was not replaced and is as originally installed during the buildings construction.

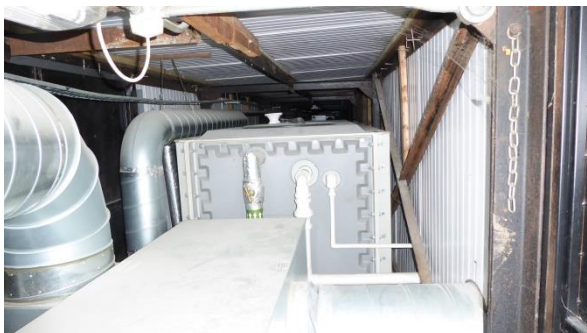
Roof Plant Area Cold
Water Storage Tanks.

The roof tanks are of a modern GRP pre-insulated construction and are scheduled to have been installed in 2010.

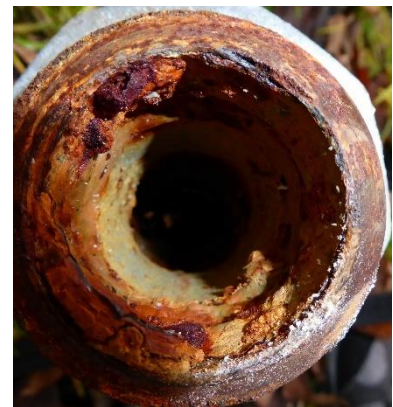
The internal condition of the pipework cannot be confirmed without cutting a section out for examination. However, galvanised pipework does corrode over time and the pipework is in excess of 45 years old. The CIBSE Guide M states that Galvanised pipework has a life expectancy of 35 years.

It is reasonable to expect the internal surfaces to be failing and any internal corrosion will start a snowball effect and cause the pipework to contaminate the pipework and water supply at an increasing rate.

The photo is of pipework from the building MCCE are currently working on to replace the water Services pipework. This building is within the Tower Hamlets area and is of a similar age to Alice Shepherd House.

This budget covers the complete renewal of the water services pipework system from ground to roof level serving. Before this work is carried out a sample of the pipework should be taken to confirm the expected condition of the pipework system. This can easily be carried out within the dwellings during a tank replacement but a large diameter section of pipe should also be cut for inspection.

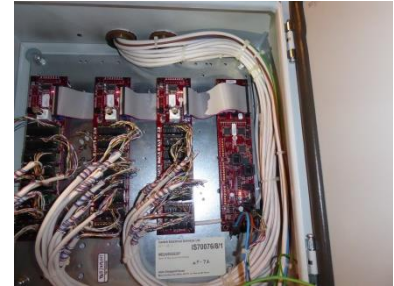
The door entry phone is an audio only entry phone system. The system was replaced in 2011 with an Entrotec Door Entry System

These systems typically last for 20 years and the budget shows replacement between 11-15 years.

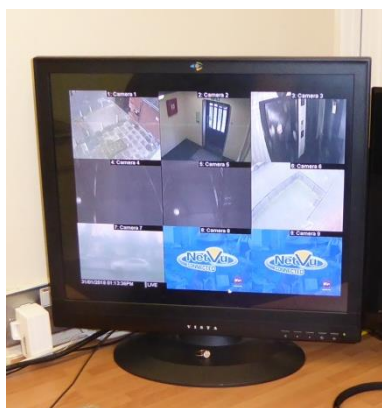
The system is housed in the concierge's office and is estimated to have been installed in 2010 although there are a number of components that have been replaced. There are only two of the nine cameras visible that appear non-operational.

The images to four of the cameras are of low quality.

CCTV Monitor.

Within the budget we have allowed for the replacement of the system in year 5 although it may be some consideration should be given to the quality of the images from the existing cameras and potentially have remedial works to these areas earlier.

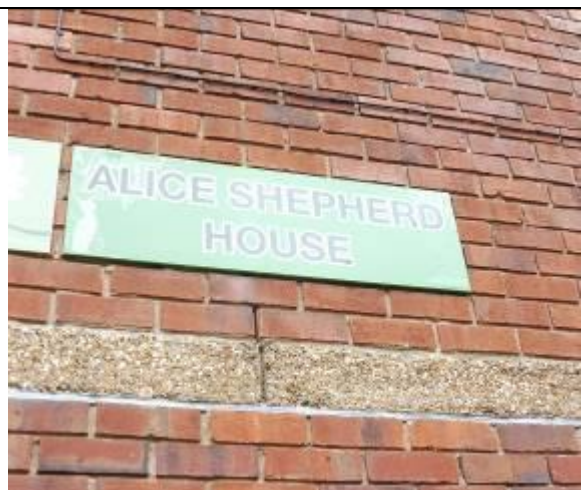
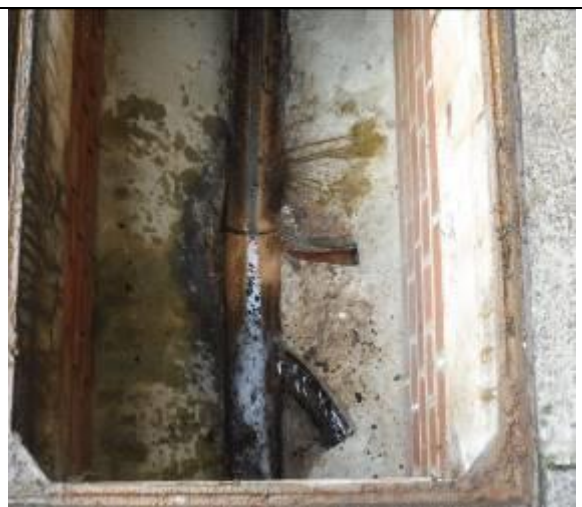
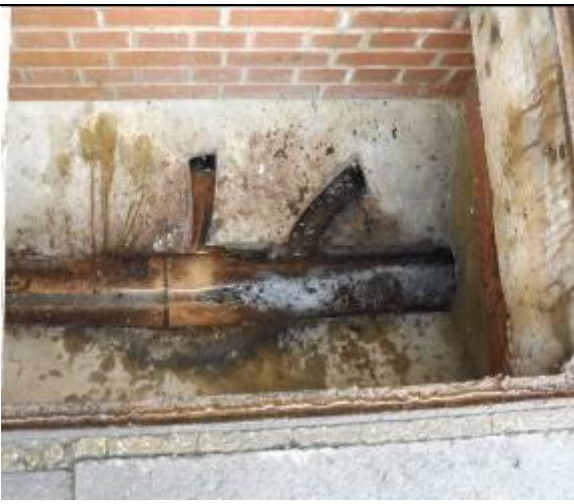
Chamber number 1

On inspection of drain survey, material of main drain is 150mm Earthenware and is in very good condition. Inspection chambers benching is also in good condition.

Due to condition of total drain run and inspection chambers I would suggest high pressure jetting of total run and greasing of chamber frames only.
