STRUCTURAL CONDITION INSPECTION REPORT
INCORPORATING LIMITED INTRUSIVE INVESTIGATION
AT
BOWSPRIT POINT
167 WESTFERRY ROAD
LONDON E14 8NU

Project Number	6627
Document Ref:	D007-A
Revision	A
Prepared by	I D Isherwood
Date prepared	24 January 2018
Client

Title: **BOWSPRIT POINT – 167 WESTFERRY ROAD – LONDON E14 8NU**

Report Following Concrete Testing

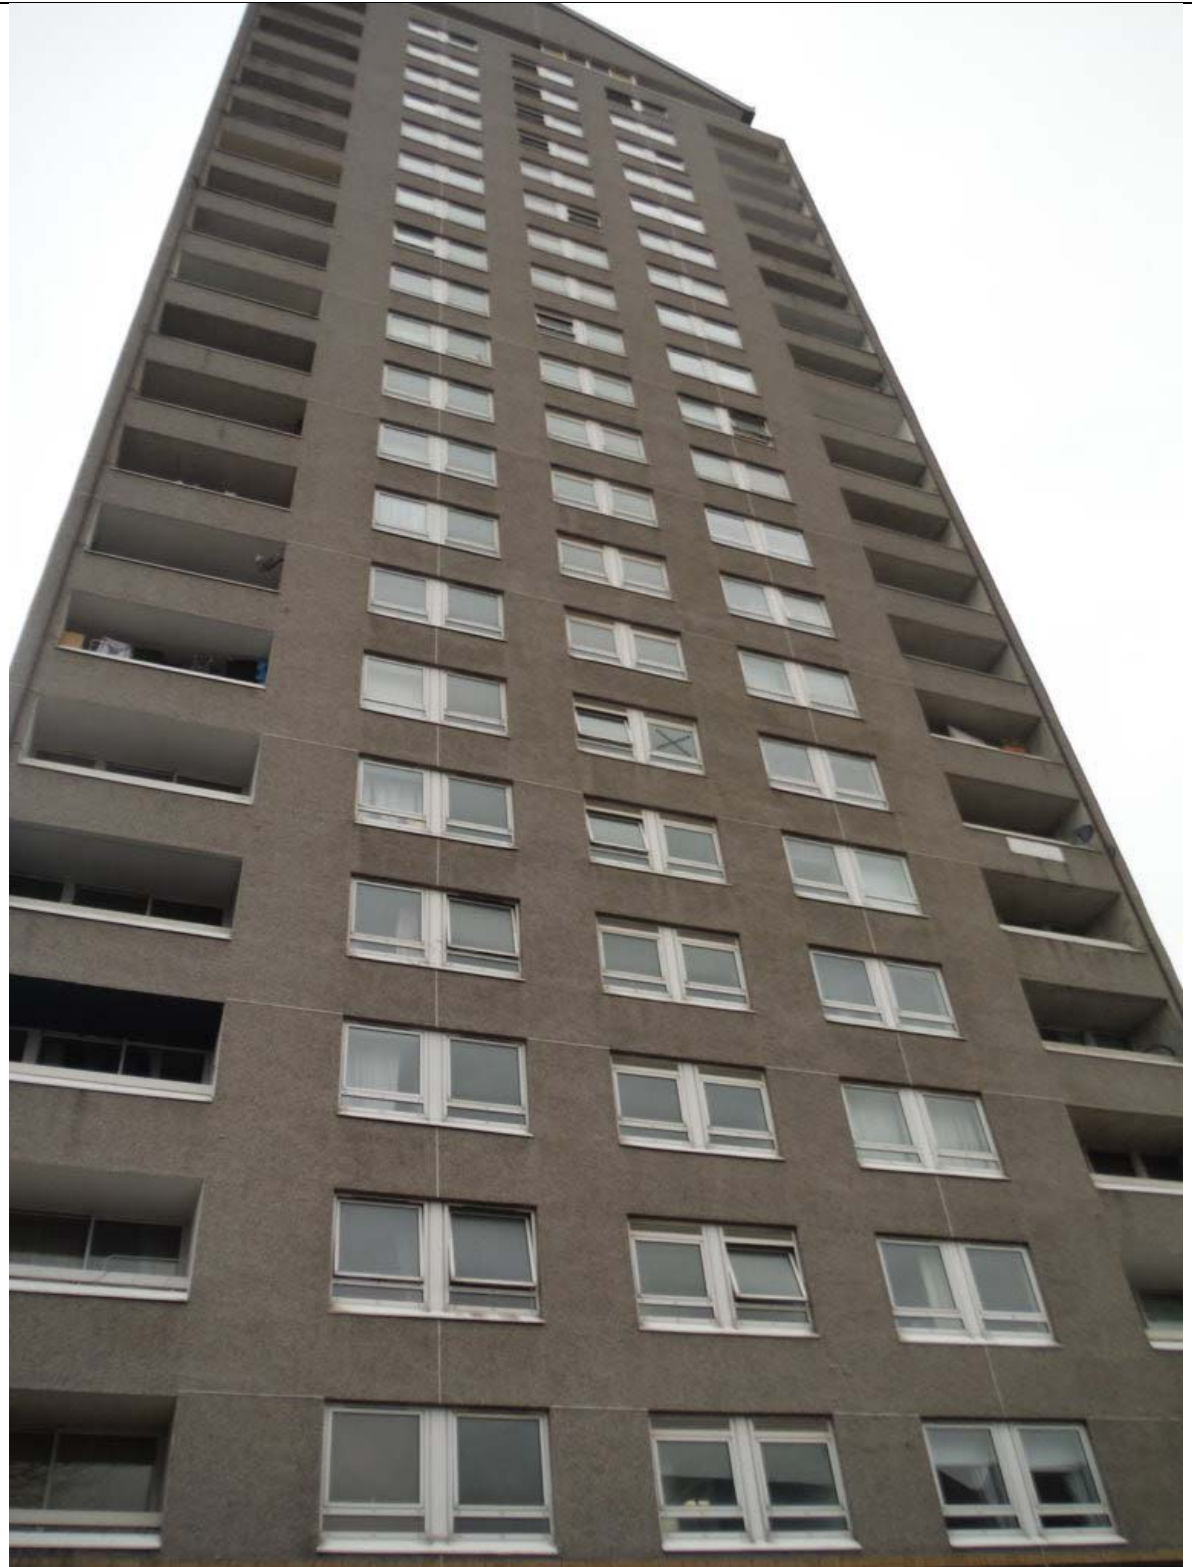
1) general view showing rendered external surfaces

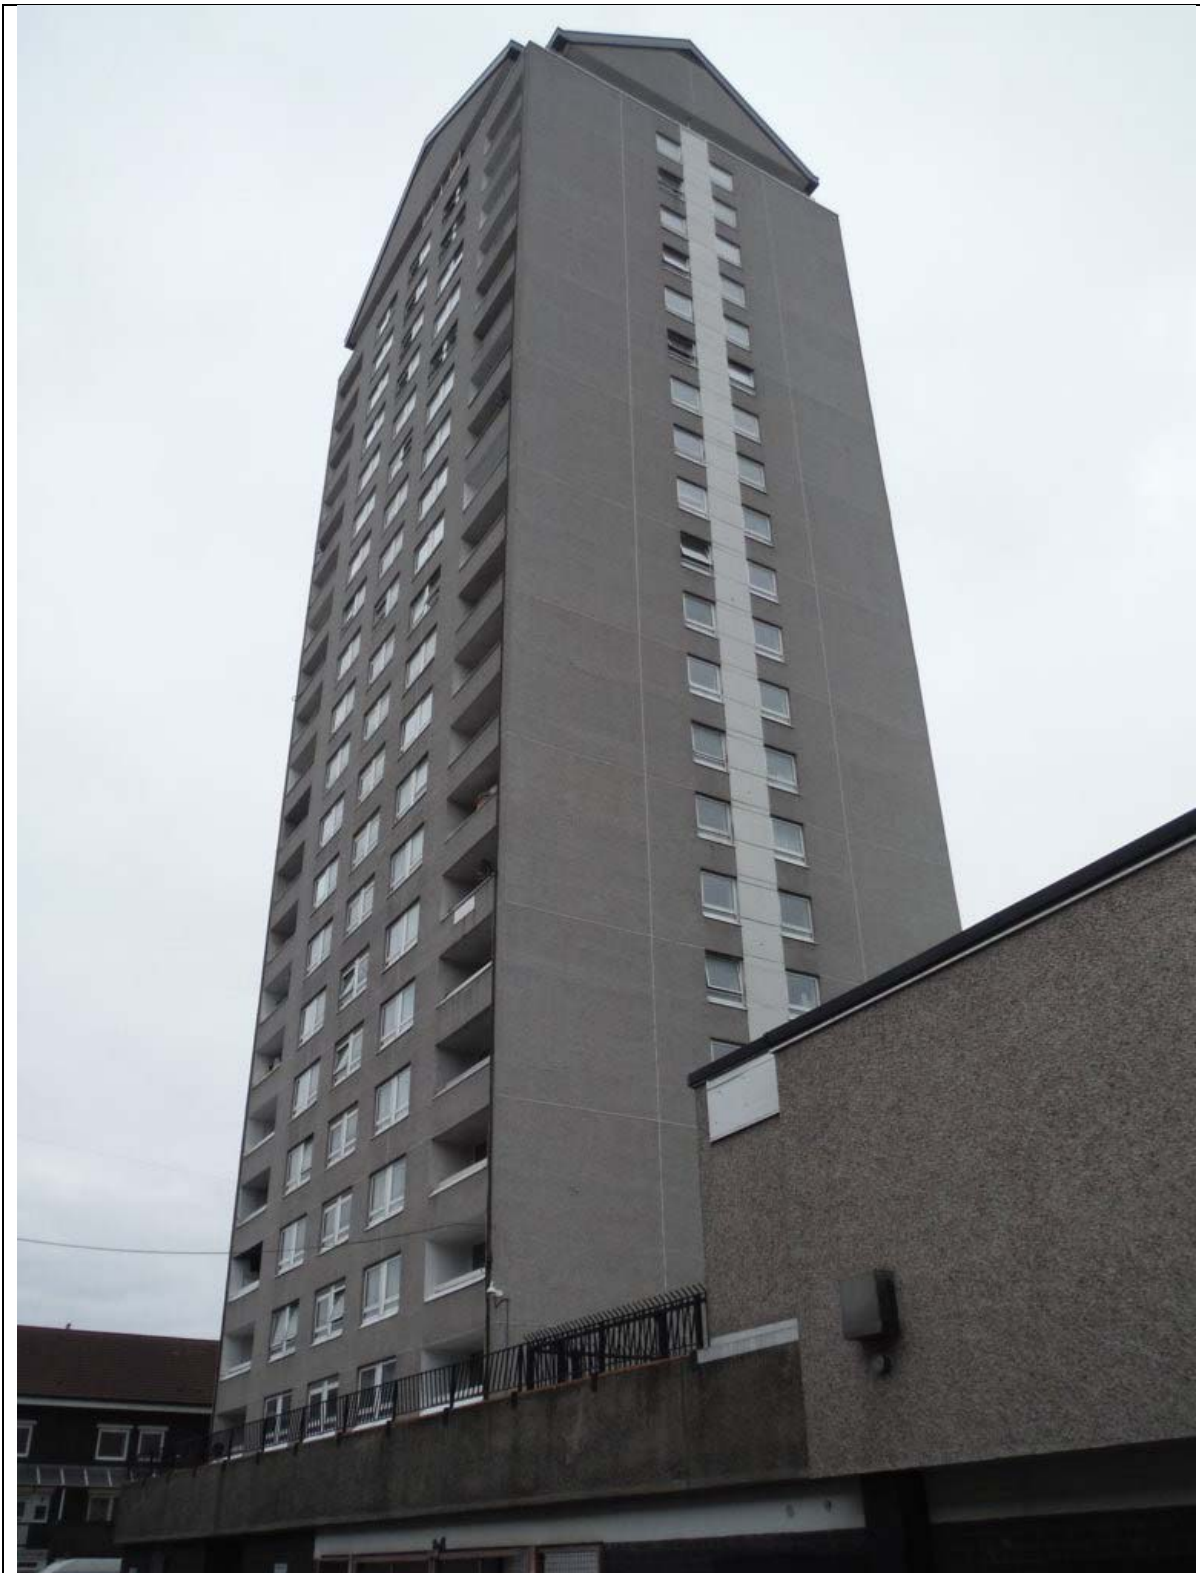
2) Rendered end wall. Pitched roof also evident.

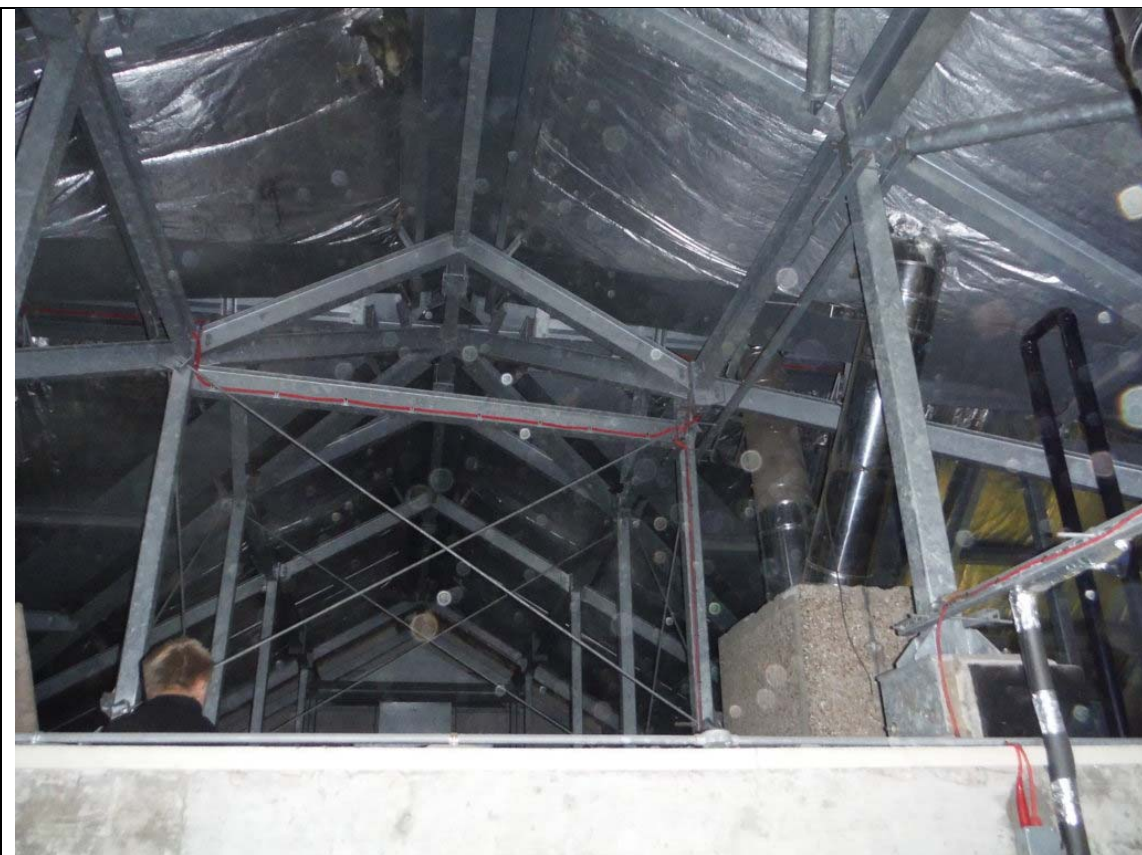
3.5) Concrete roof members including plant room walls etc. are over-clad by a pitched metal framed roof structure.

3) internal view of metal framed pitched roof

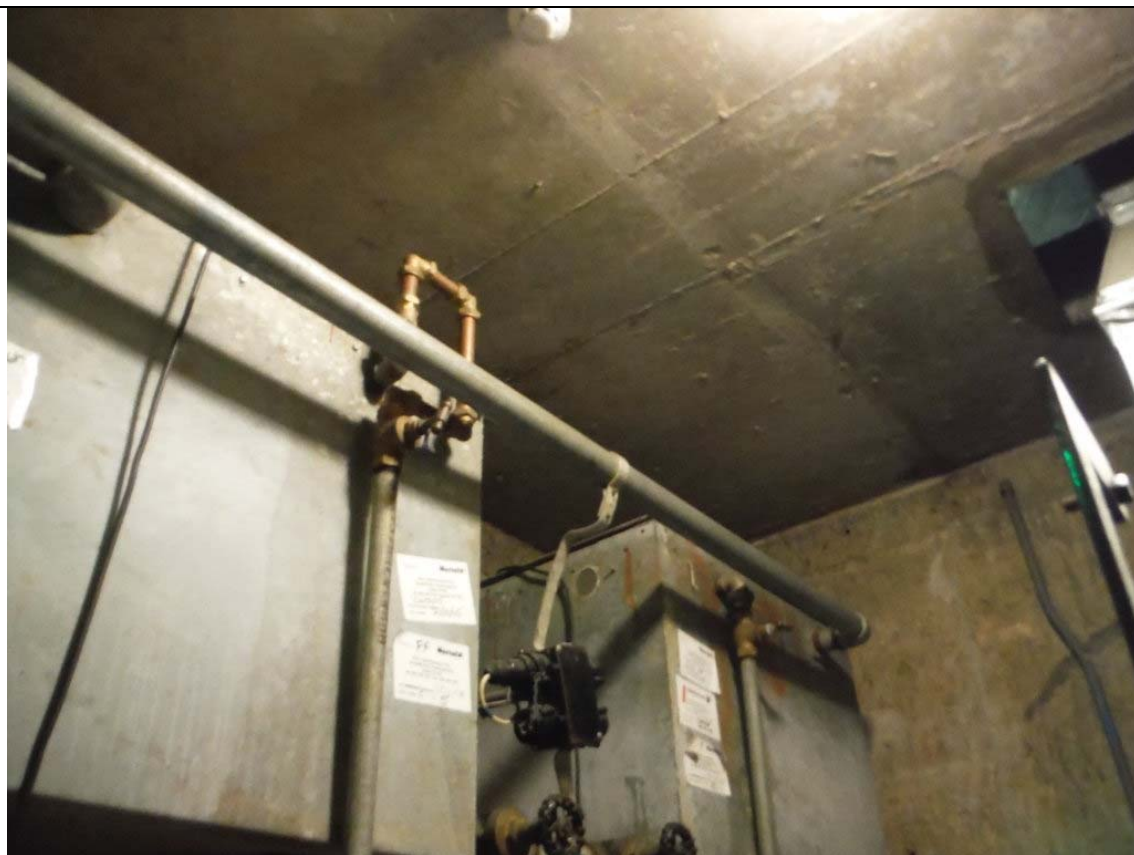
4) tank room roof and walls of in-situ concrete

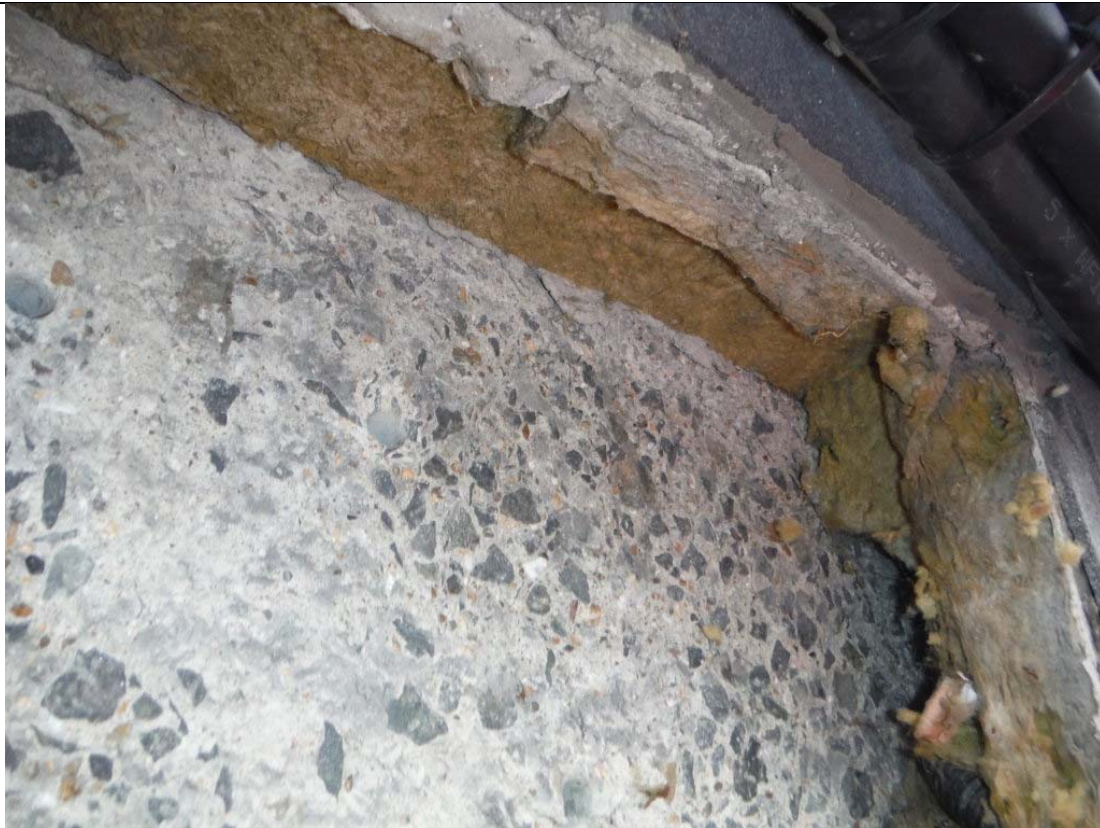
5) Mineral wool insulation between concrete and brick façade at 1st floor level

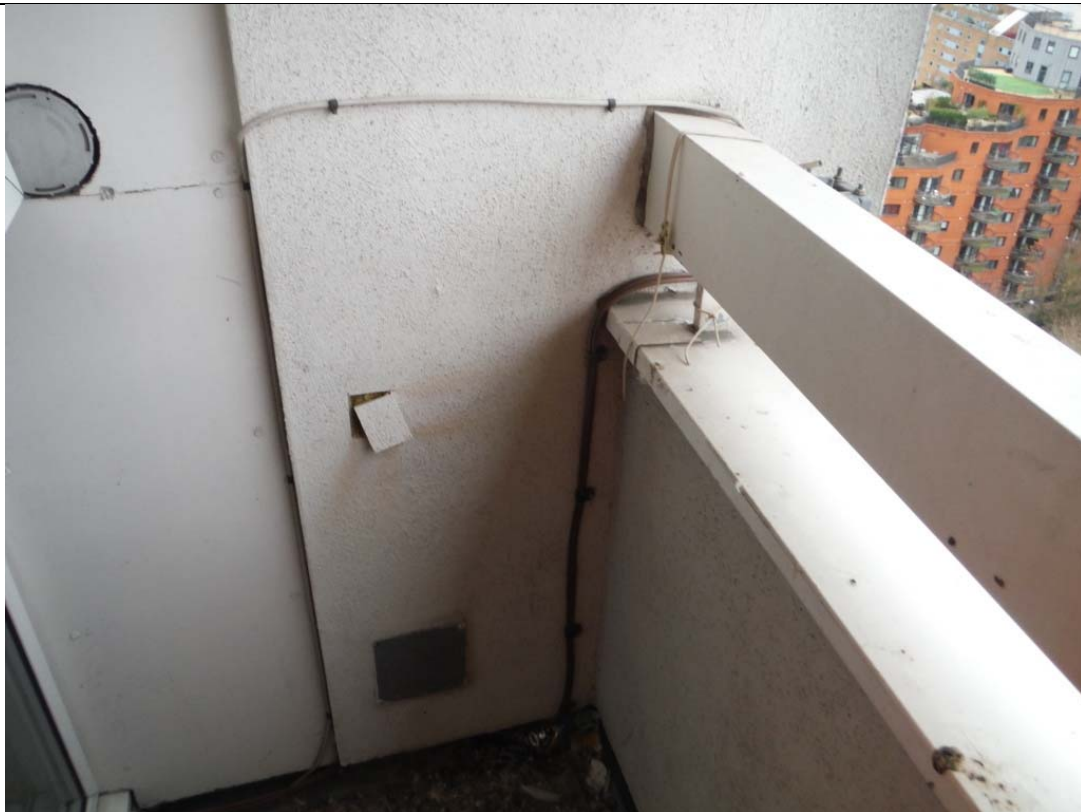
6) Insulated render cladding to upper storey cross wall to balcony

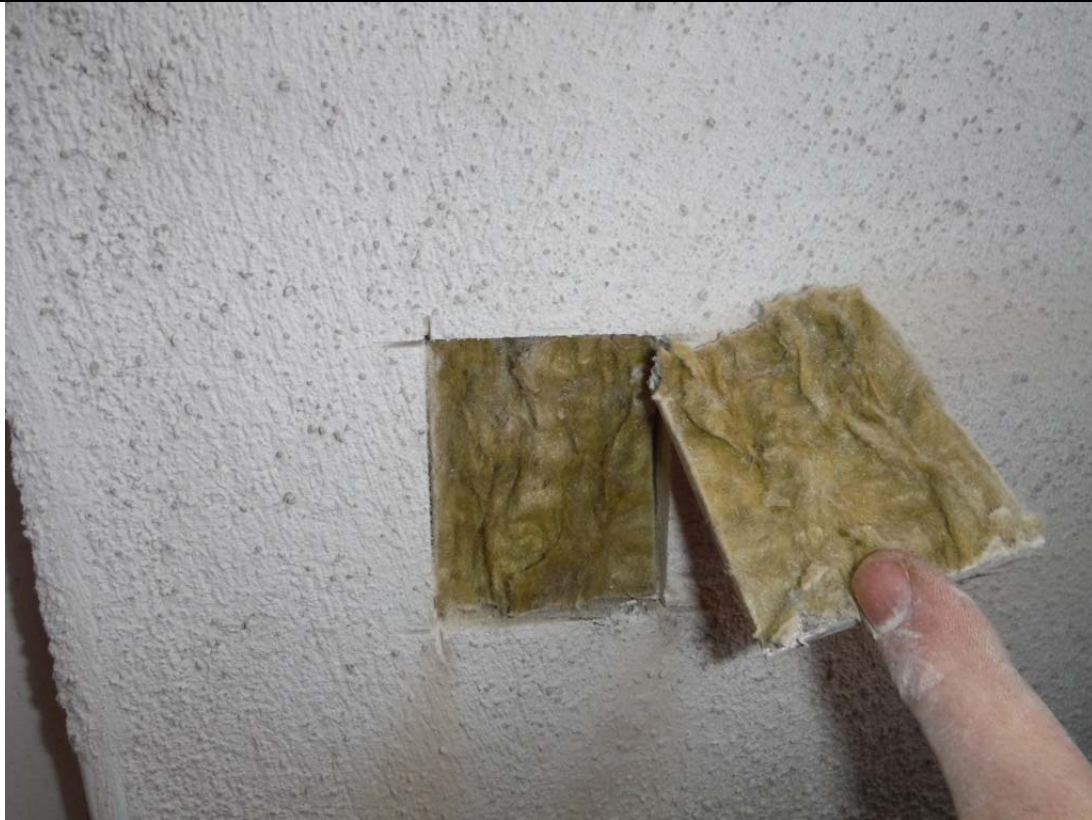
3.4) The block is rendered externally with render on mineral wool insulation which is fixed directly to the original concrete substrate with no formed void evident. Due to the render it is not possible to comment on the general condition of the external frame or cladding elements.

7) mineral wool insulation fully filling behind render to balcony cross wall

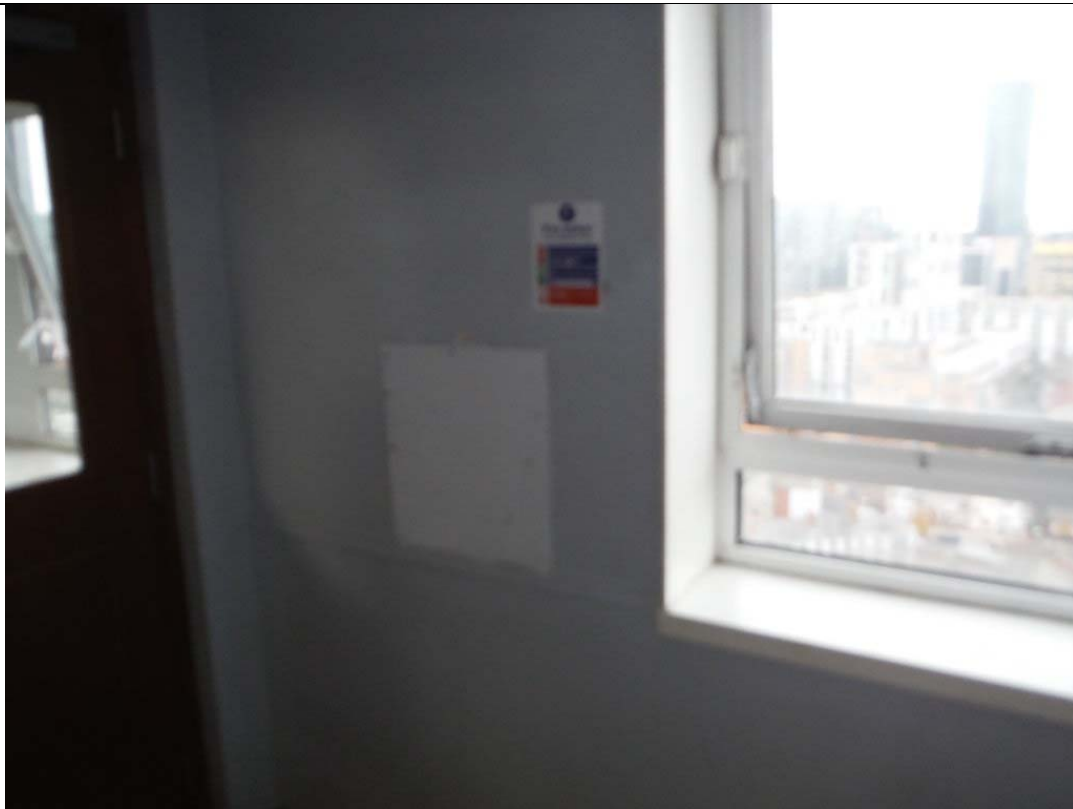
8) Wall panel to upper floor stairwell similar to other “point” blocks

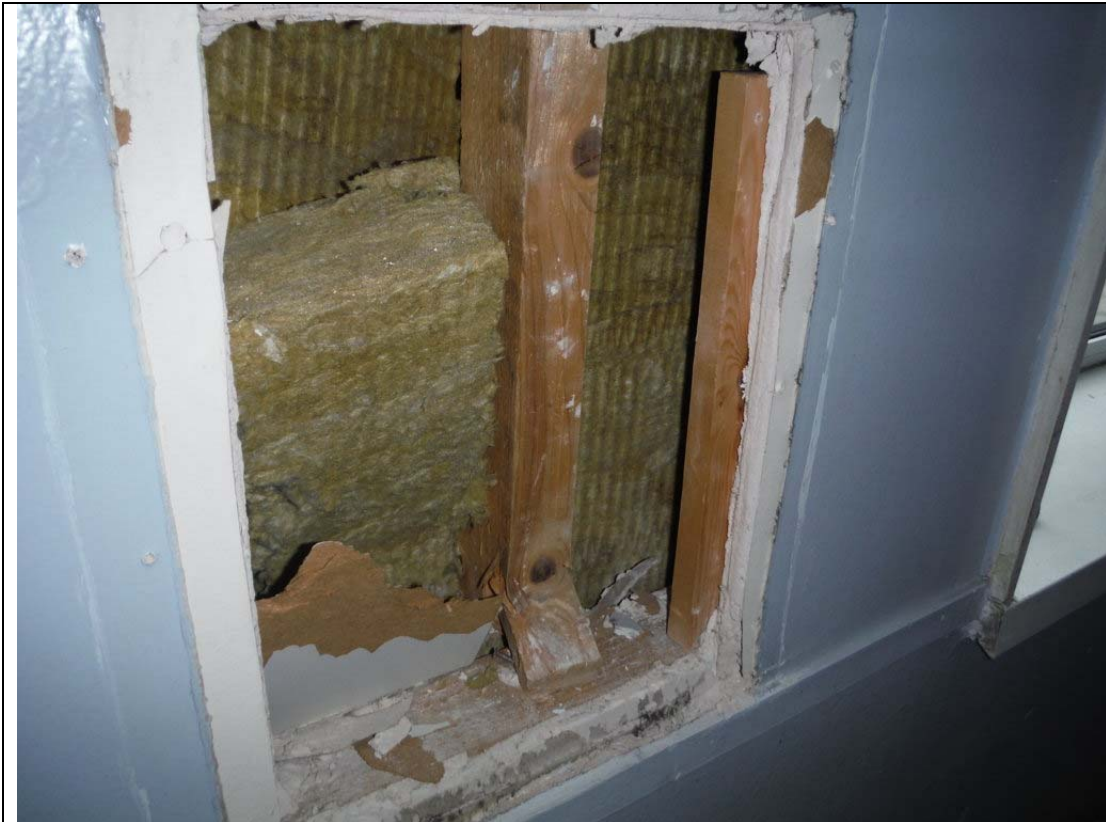
3.4.1) There are some areas of infill within the stairwells (evident by internal timber panels) which are enclosing presumed previous areas of glazing. These are filled with lightweight blockwork, mineral wool insulation and plasterboard on a timber frame.

9) mineral wool batts partially filling void presumed to be originally glazed

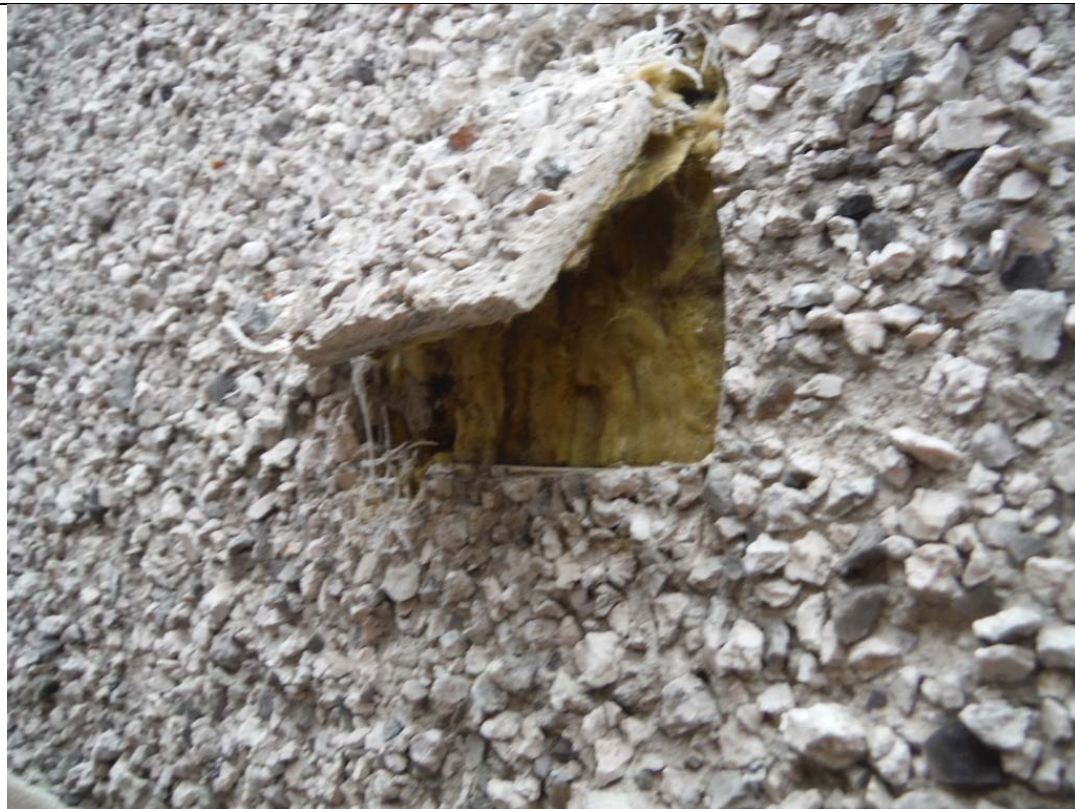
10) mineral wool insulation behind aggregate faced render

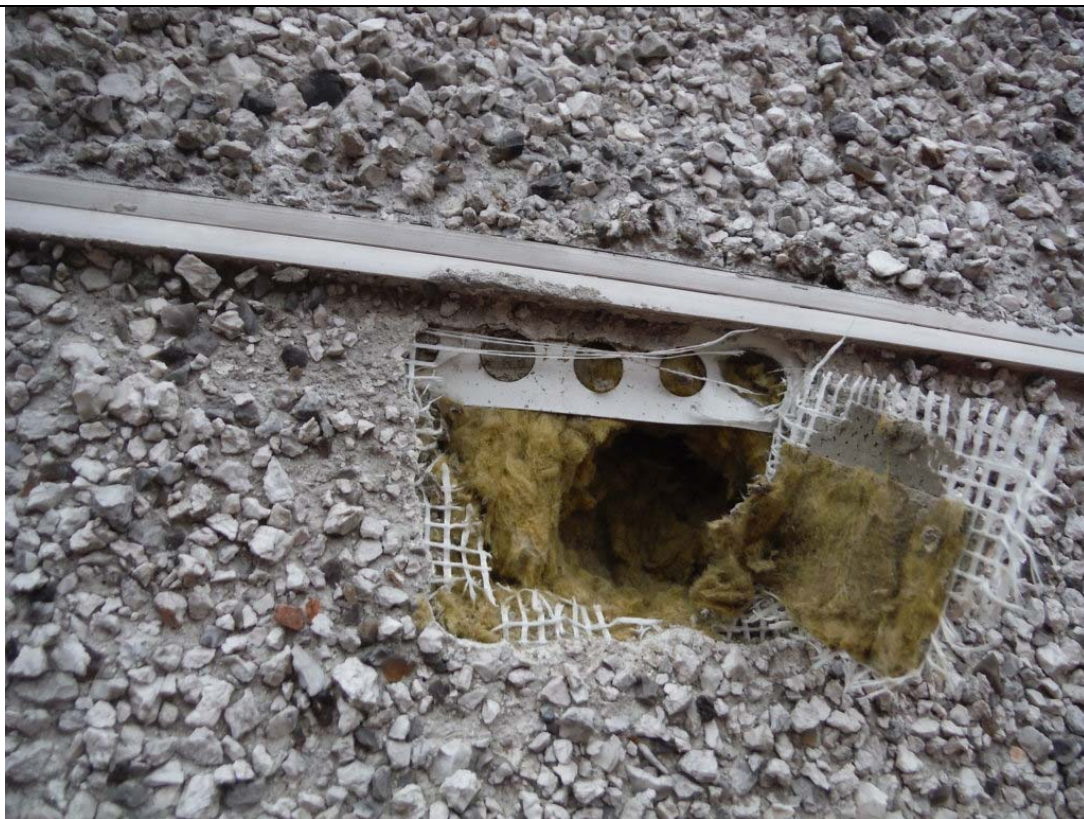
12) mineral wool filling behind render at render panel boundary
