STRUCTURAL CONDITION INSPECTION REPORT
INCORPORATING LIMITED INTRUSIVE INVESTIGATION
AT
KELSON HOUSE
STEWART STREET
LONDON E14 3JQ

Project Number	6627
Document Ref:	D013-A
Revision	A
Prepared by	I D Isherwood
Date prepared	24 January 2018
Client

Title: **KELSON HOUSE – STEWART STREET – LONDON E14 3JQ**

9. Appendix - Constructive Evaluation Report KELSON HOUSE

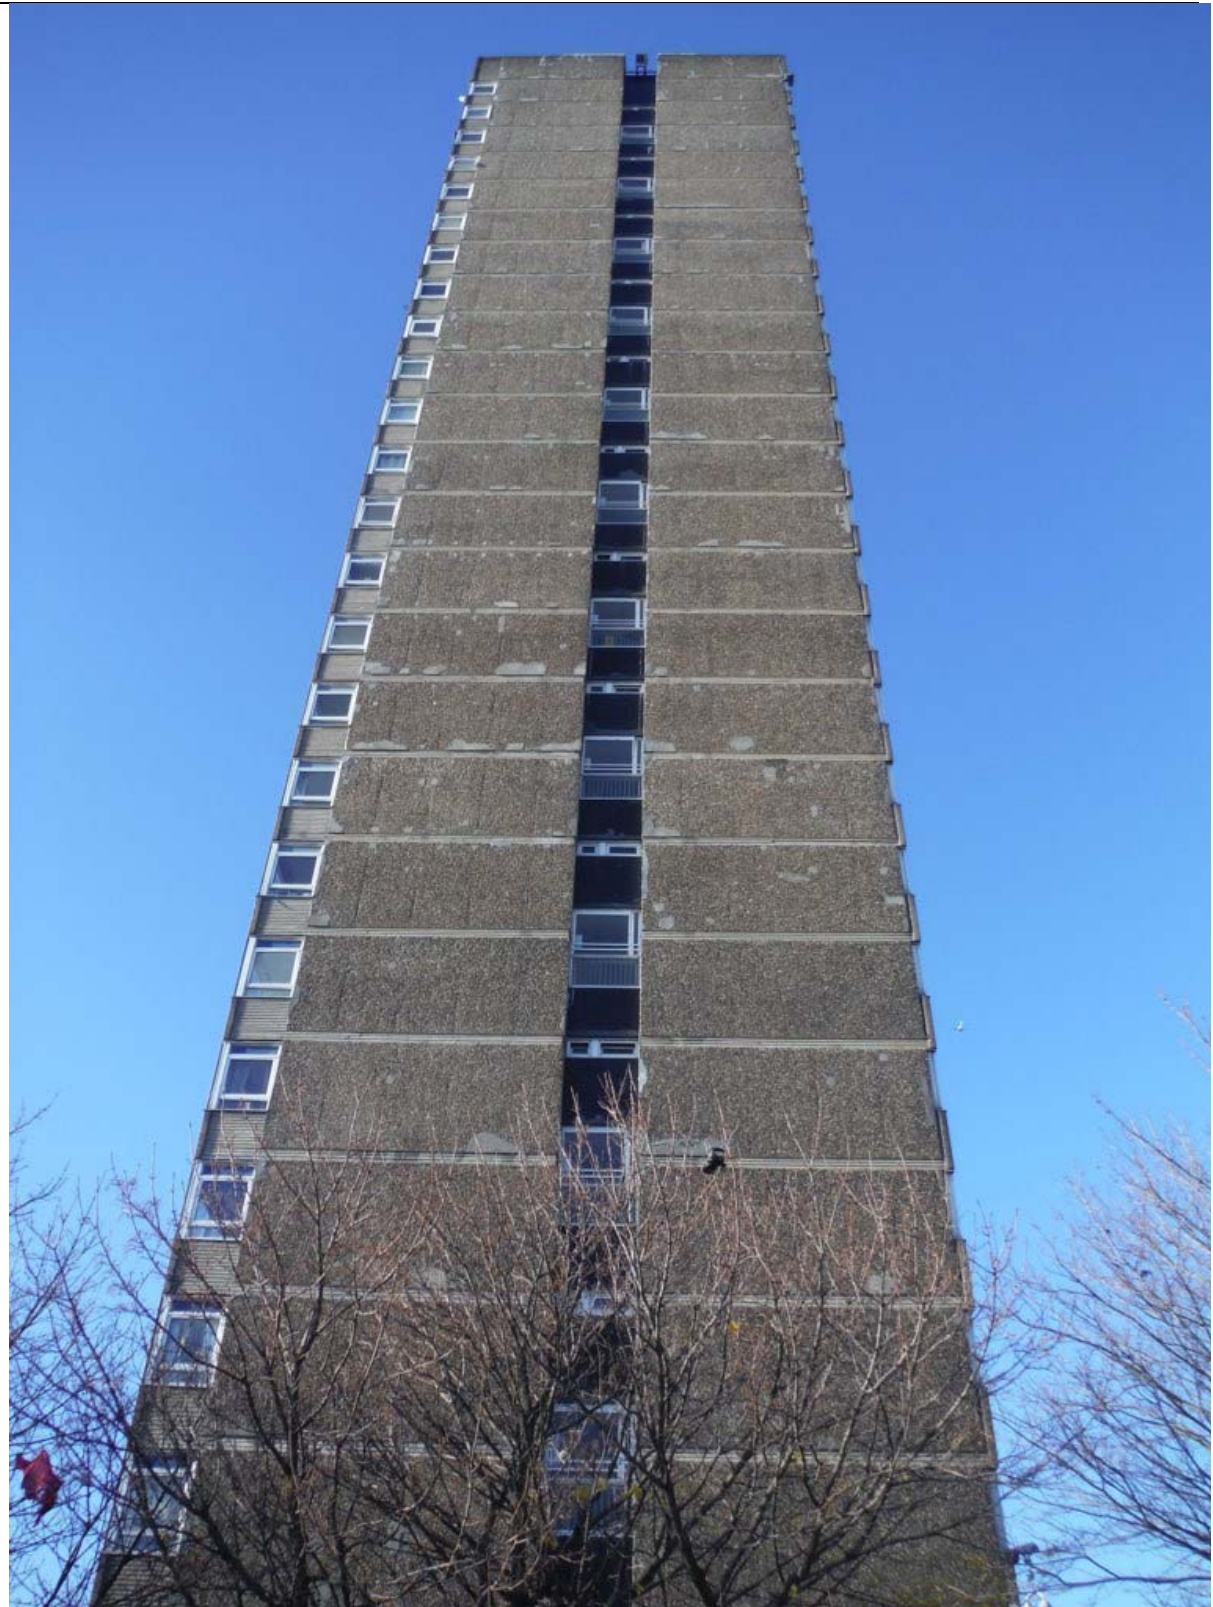
3.15) There are a significant number of repairs to the East end, exposed aggregate finished wall. The repairs are not square cut and therefore may be prone to early failure. There is evidence of cement washout (of the original material) due to water and (possibly) wind scour and the aggregate is therefore no longer as well bedded as it once was. There are also a number of vertical striations which are presumed to be the result of years of water running down the wall. There was no evidence of exposed reinforcement at striations although the inspection was completed from ground level through binoculars.

3) Kelson House, East end showing multiple repairs and striations (predominantly left side).

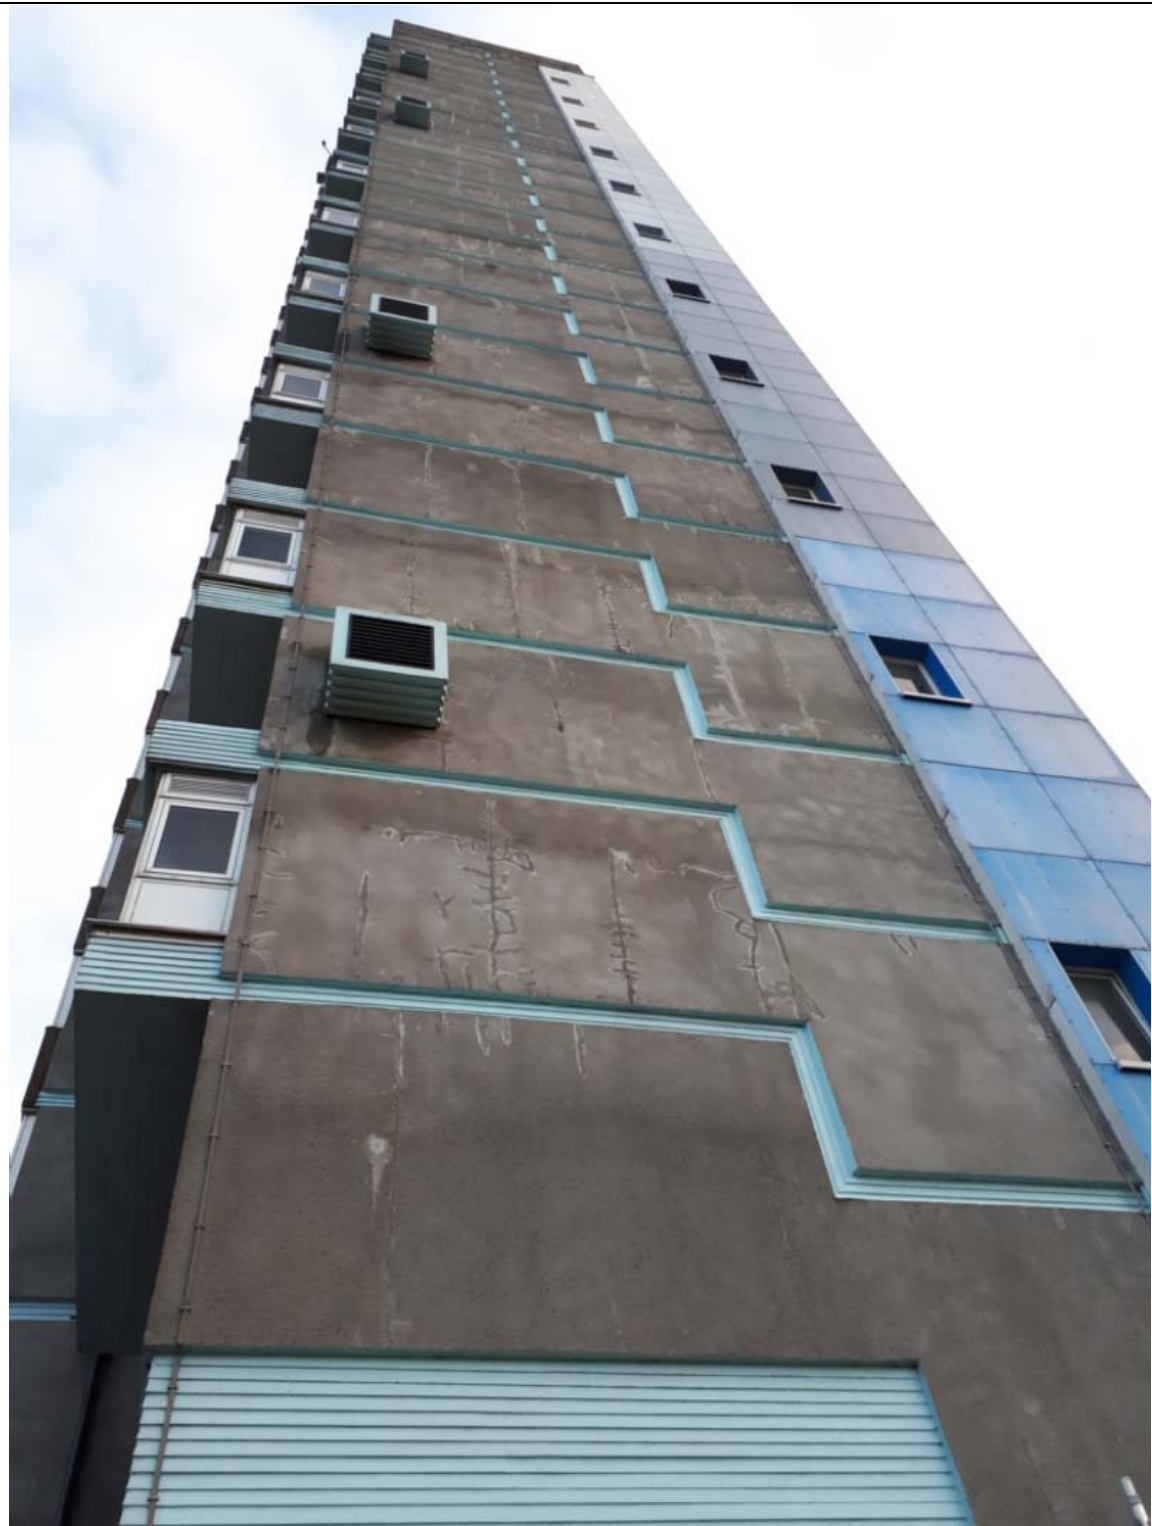
4) Kelson House West end showing shiplap pattern concrete (light blue) and grey render with multiple repairs.

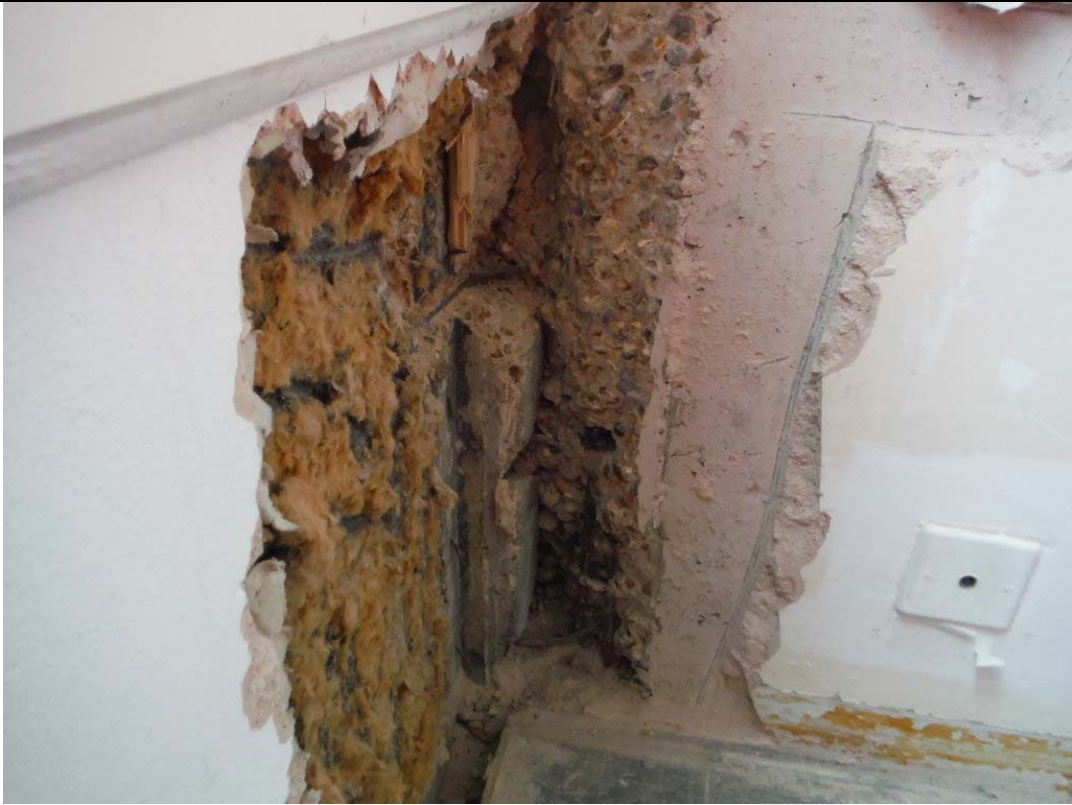
- 4.3 The end of the cross walls link into to the exposed aggregate precast panels. Sample exposure of the connection revealed reinforcement tie back to the walls to be in good condition with no signs of rusting or decay.

5) junction of cladding and cross wall

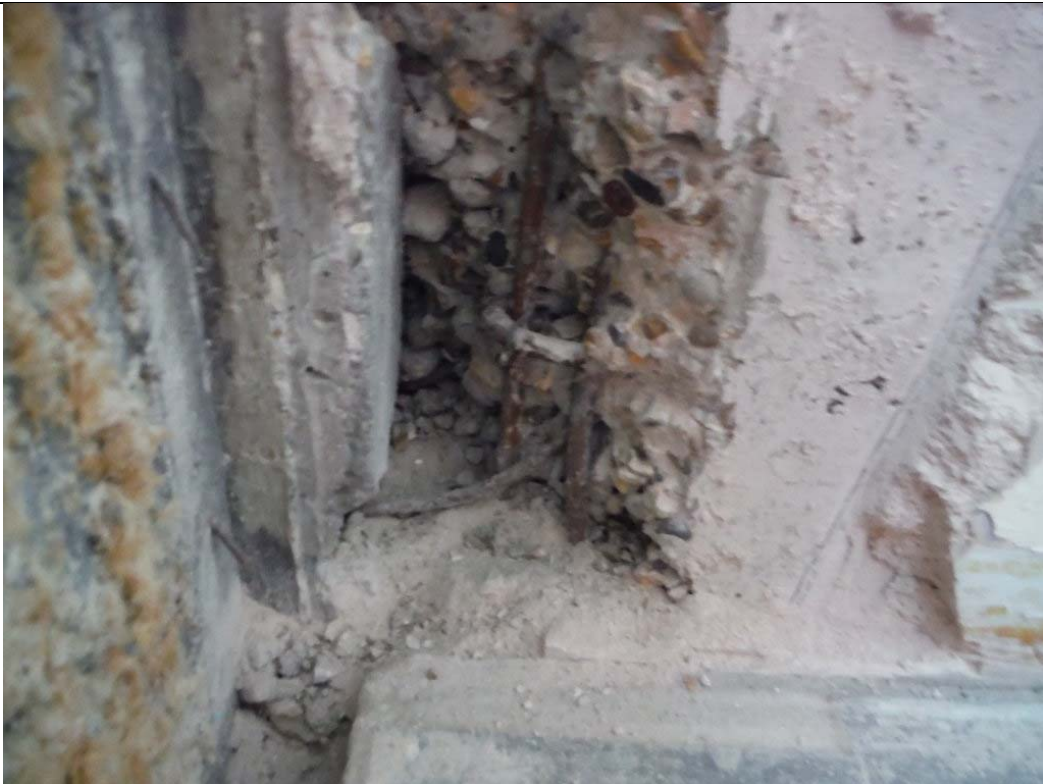
3.5) The pre-cast (externally aggregate faced) cladding panels are attached to cross walls by 4no 6mm smooth mild steel (SMS) bars which appeared to be in fair condition where broken out. It is presumed that all other positions are similarly fixed however we are not able to confirm this. The bars are cast into the pre-cast planks and the walls (at connection point) must have been cast after the panels were put into position.

6) 6mm bar connecting panel to cross wall. Wall reinforcement also evident

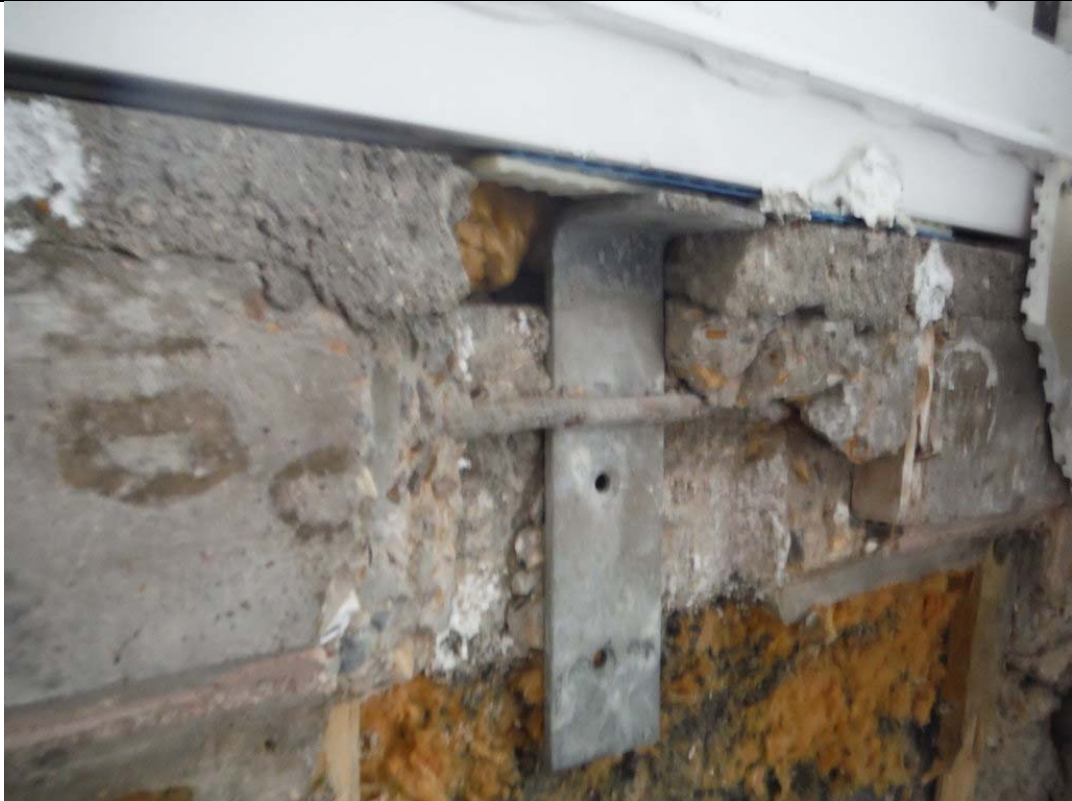
7) probable angle bracket for original metal frames windows

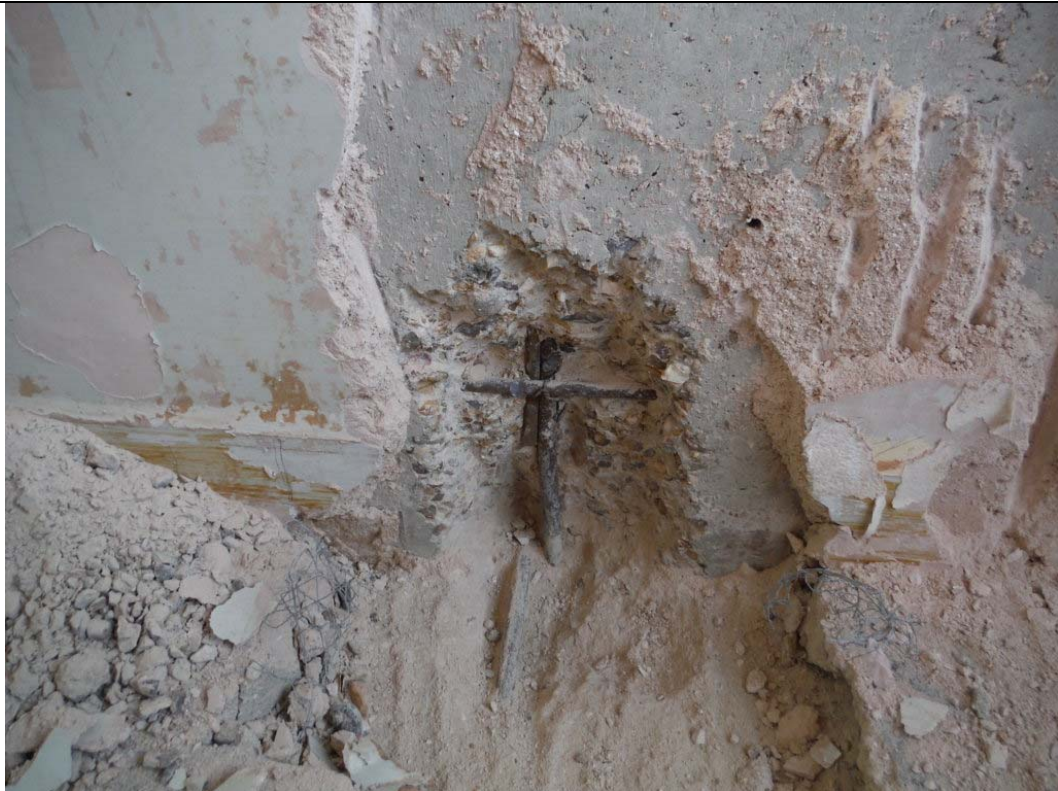
- 4.1 No visible, significant or concerning signs of structural distress or movement were identified.
- 4.2 Exposure of the floor to internal wall joint revealed reinforcement in the walls linking with the floor rebar. No deleterious condition was observed.

8) floor to cross wall junction showing floor reinforcement protruding into wall

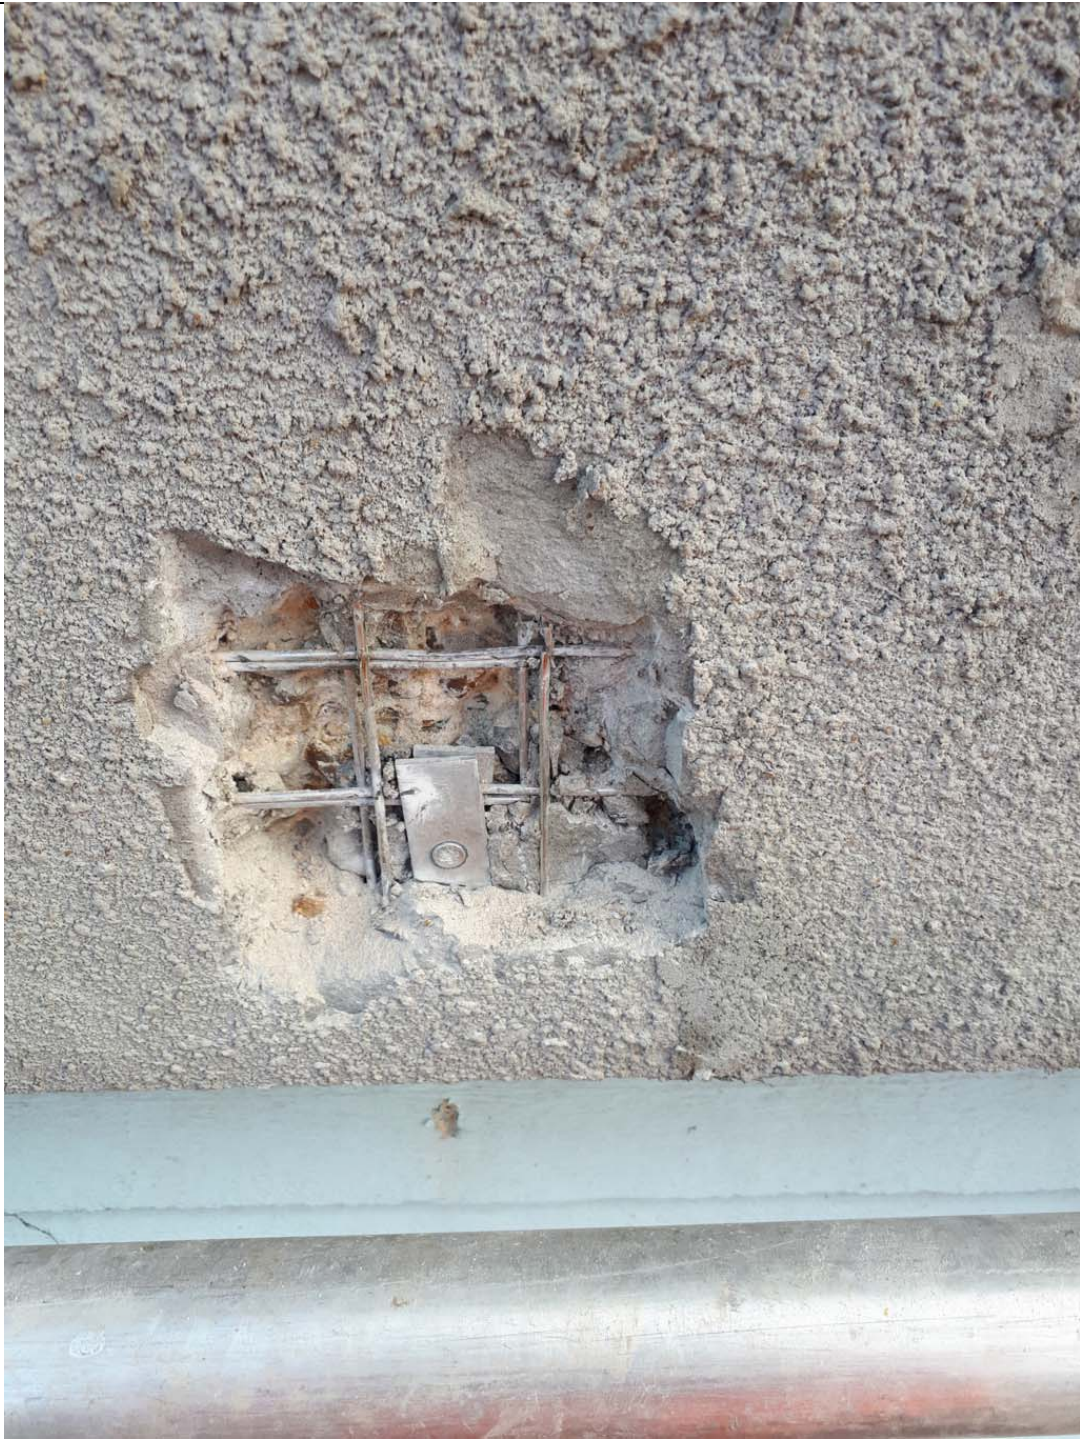
3.12) The render coating to the West end lift/ stairwell core wall is a proprietary cementitious material with 3mm stainless steel mesh reinforcement (50mm grid). The render is 30mm thick, cast in 2 no coats with 20mm cover to the mesh. The render is applied directly onto the concrete substrate. Repairs completed appear to be untidy and inspection from ground level suggests that repair work may be required at 11th and 21st floors to make the render watertight.

9) West end render broken out revealing stainless mesh and concrete substrate

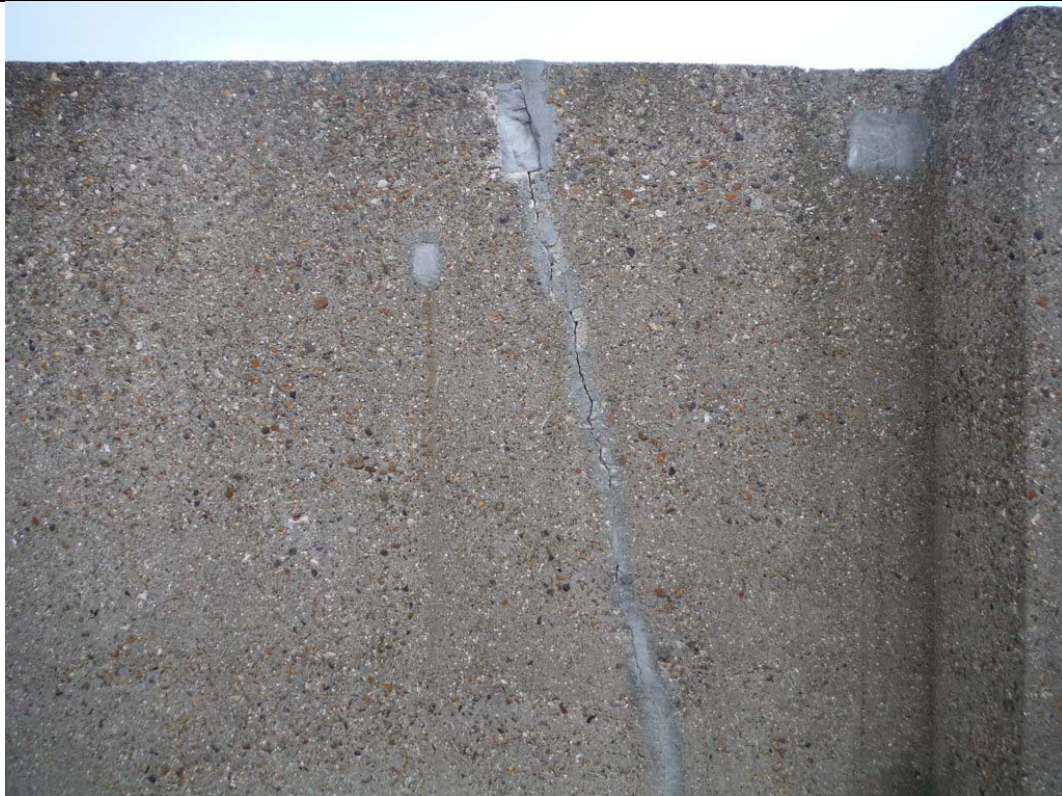
3.13) Cracking is evident to the inner faces of the large parapet walls. The crack pattern suggests thermal movement as the cause. The cracking does not appear to continue through the full thickness of the parapets however it must be recognised that the inspection of the parapets was completed from ground level through binoculars.

10) typical crack to parapet with failed repairs

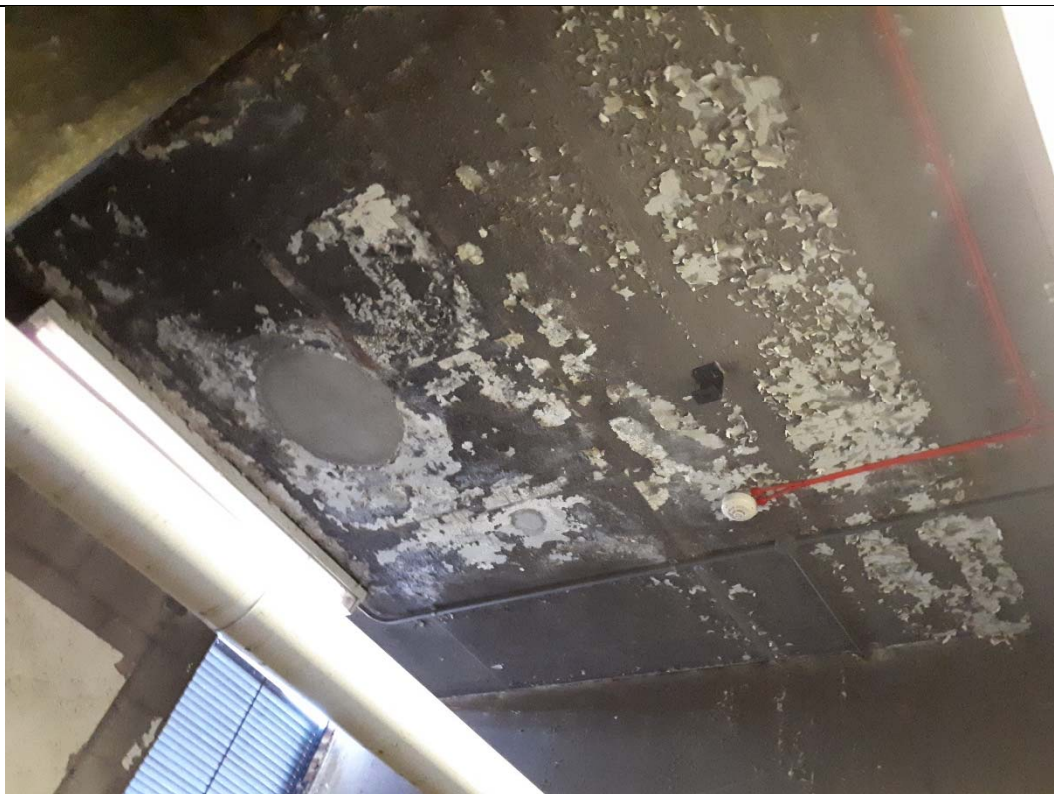
3.14) The decorative finishes to the rooftop plantroom roof and walls are generally disrupted/ blistered. There is evidence of localised water ingress although little evidence of spall or significantly affected concrete.

11) blistered paintwork to plantroom ceiling

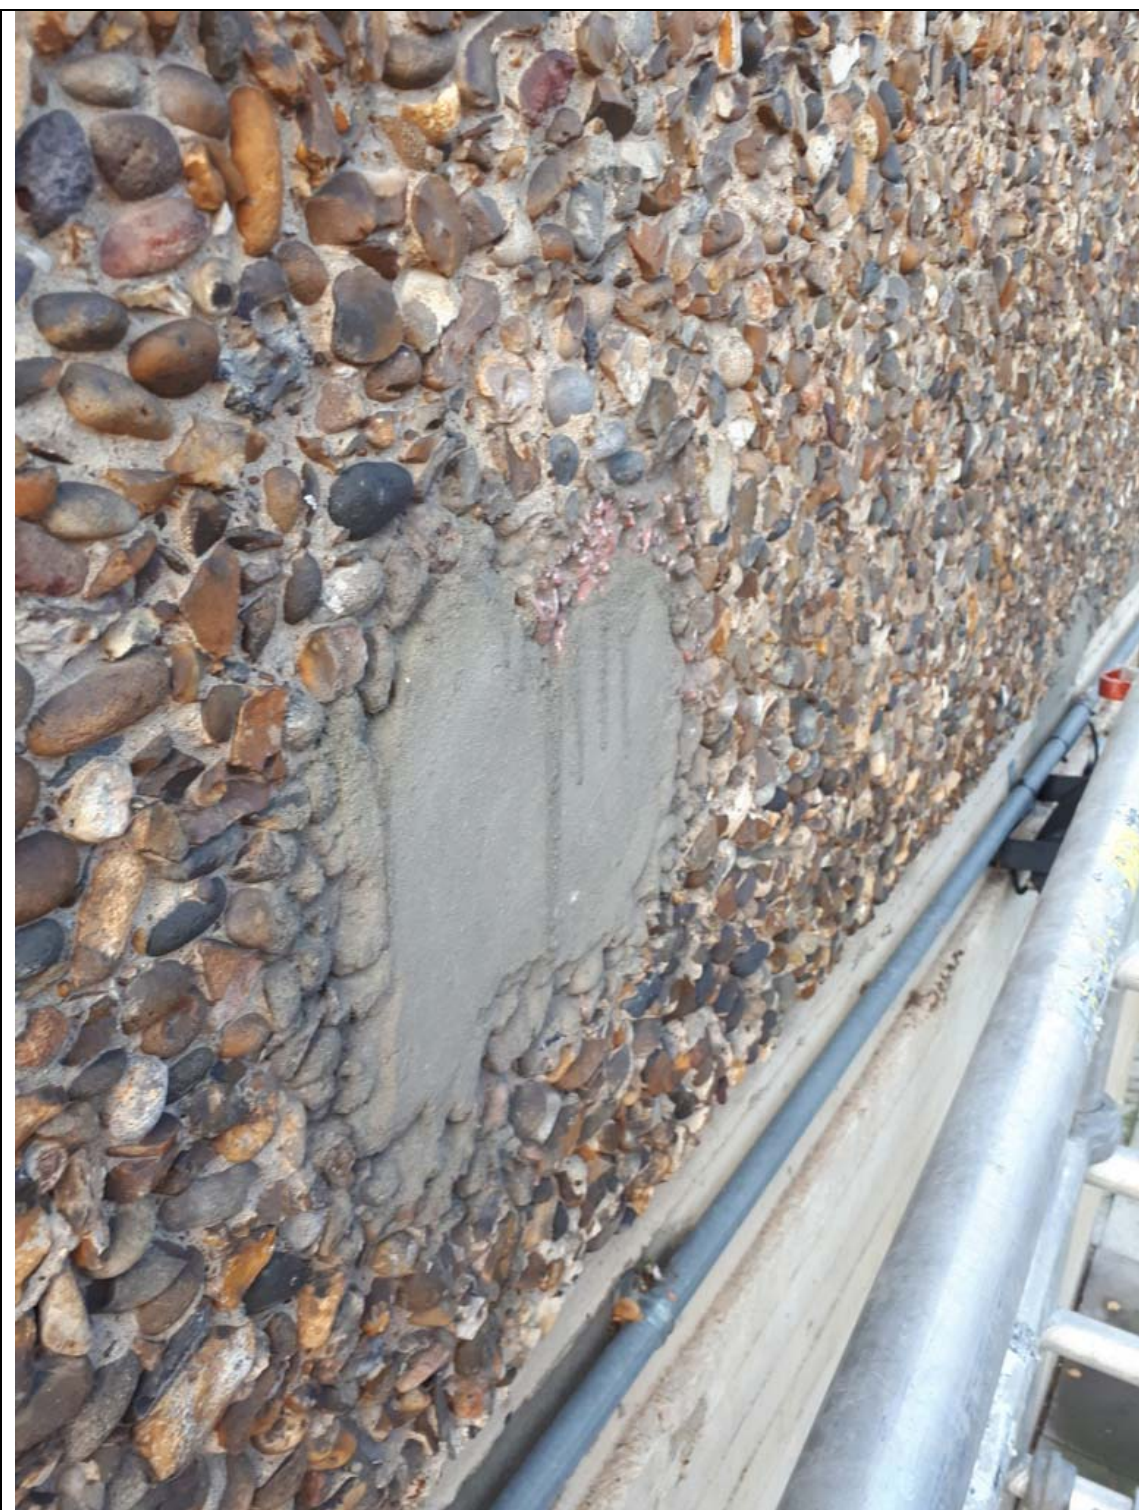
12) repair to East end wall. Aggregate is very exposed due partly to cement wash out.

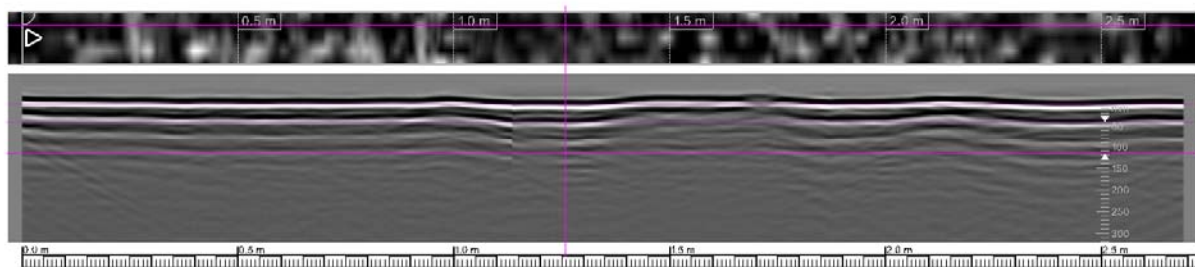
Project name:	Kelson House	Customer:	-One Housing
Location:	-London	Object:	-slab
User:	-pg		
Comment:	-quick scan to East side floor adjacent to cladding. No obvious large deflections suggesting fixings.

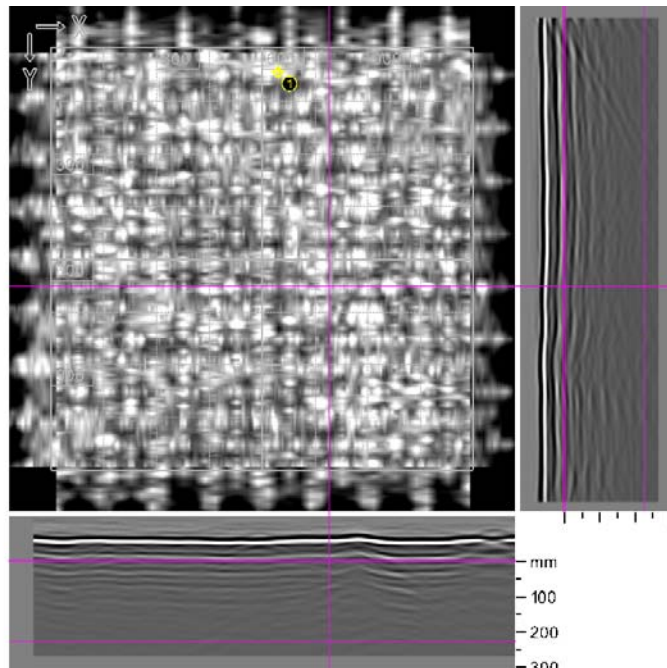
Project name: Kelson House Customer: -One Housing
Location: -London Object: -slab
User: -pg
Comment: -scan to East side adjacent to cladding panel. No obvious fixing evident although signal significantly disturbed by chicken wire reinforcement within screed

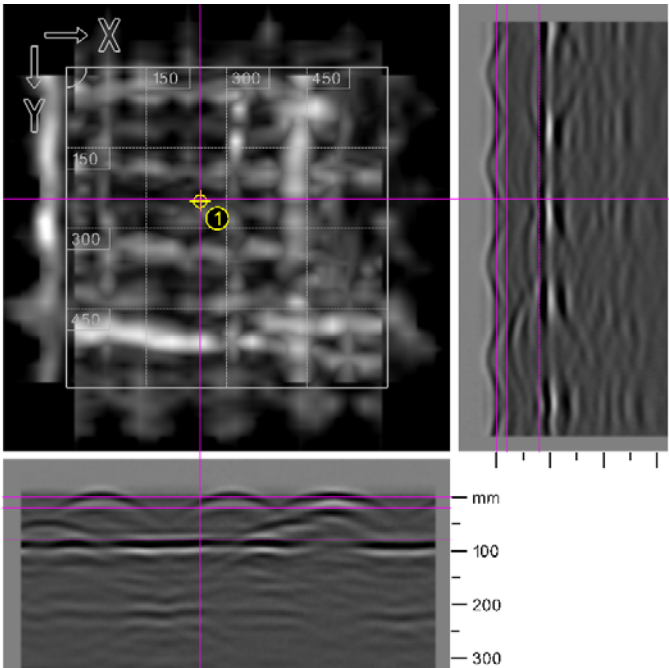
Project name: Kelson House Customer: -One Housing
Location: -London Object: -ceiling
User: -pg
Comment: -scan to ceiling adjacent to East side windows. 2no layers of bars at approximately 150mm centres in both directions. Possible slab depth circa 250mm

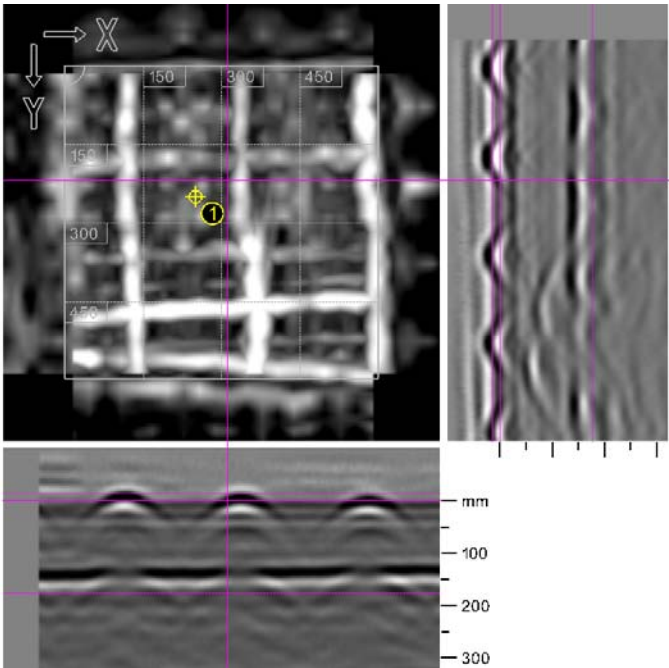
Project name:	Kelson House	Customer:	-One Housing
Location:	-London	Object:	-Ceiling
User:	-pg		
Comment:	-scan to East side ceiling adjacent to windows. 2no layers of bars at variable spacing. No clear evidence of fixing.

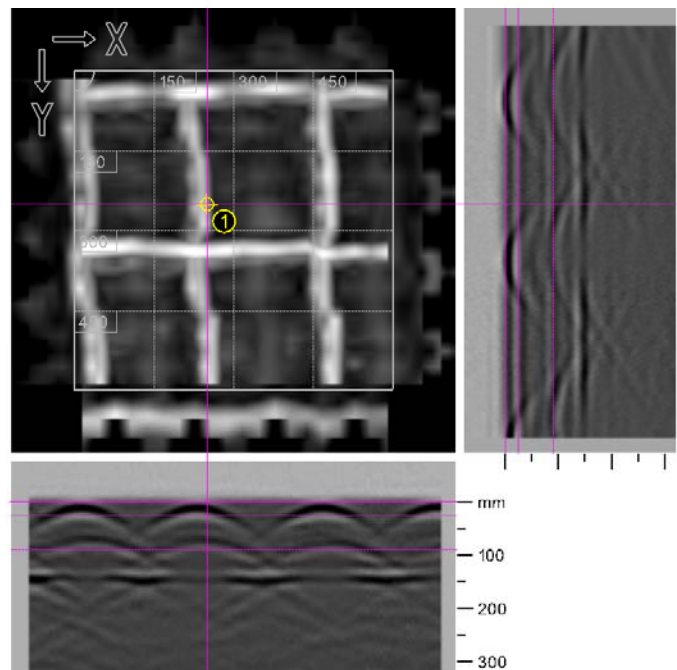
Project name:	Kelson House	Customer:	-One Housing
Location:	-London	Object:	-Wall
User:	-pg		
Comment:	-scan to party wall suggests 3no layers of bars. Possible wall thickness circa 150mm

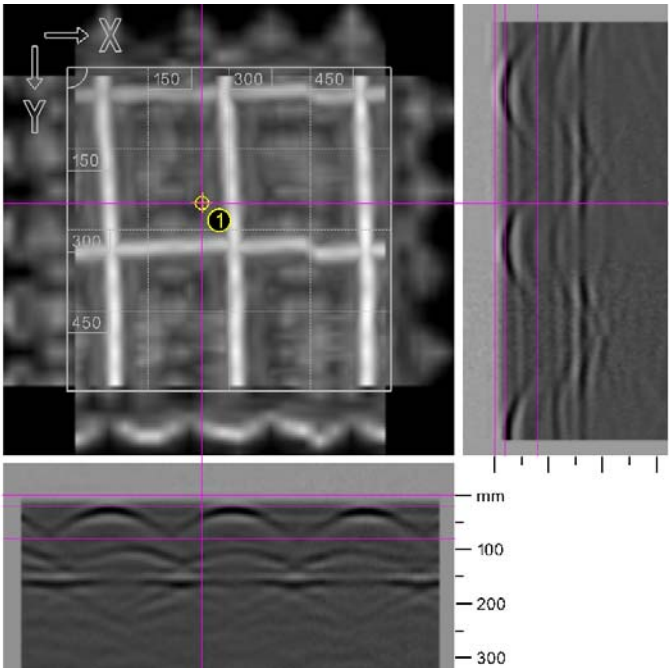
Project name:	Kelson House	Customer:	-One Housing
Location:	-London	Object:	-Wall
User:	-pg		
Comment:	-scan to wall suggests 2no layers of bars, 225mm vertical spacing, 300mm horizontal spacing. Wall possibly circa 150mm thick

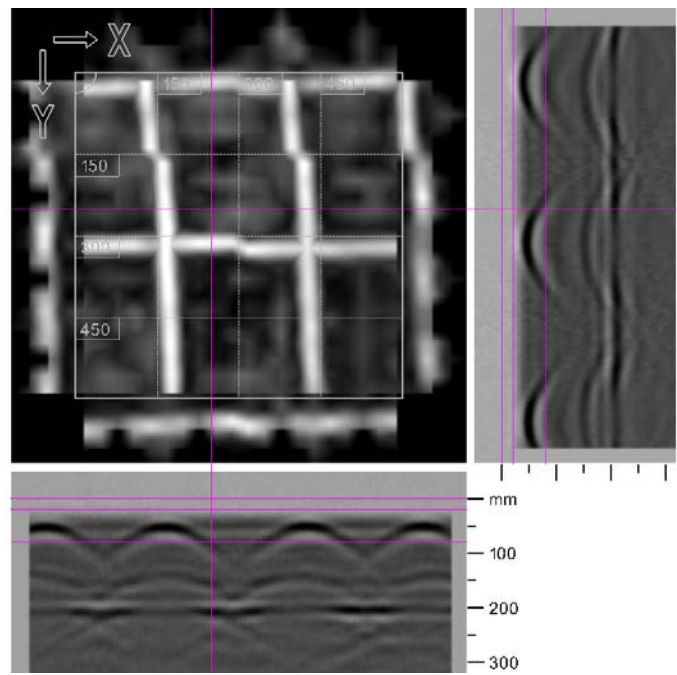
Project name:	Kelson House	Customer:	-One Housing
Location:	-London	Object:	-Wall
User:	-pg		
Comment:	-scan to party wall suggests 3no layers of reinforcement. Wall thickness circa 200mm

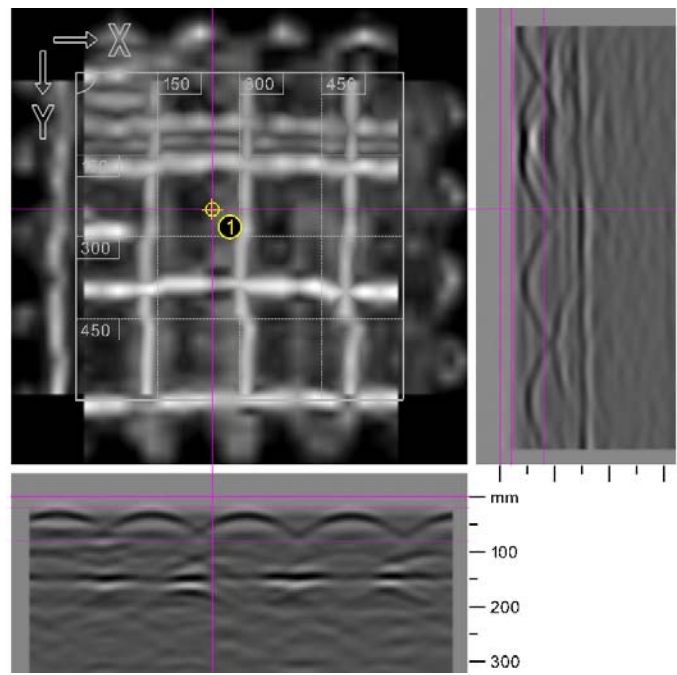
Project name:	Kelson House	Customer:	-One Housing
Location:	-London	Object:	-Ceiling
User:	-pg		
Comment:	-scan to ceiling adjacent to party wall. Analysis suggests 2no layers of bars. Slab thickness > 150mm. no obvious fixing/ tie detail evident.
