STRUCTURAL CONDITION INSPECTION REPORT
INCORPORATING LIMITED INTRUSIVE INVESTIGATION
AT
KNIGHTHEAD POINT
THE QUARTERDECK
LONDON E14 8SR

Project Number	6627
Document Ref:	D008-A
Revision	A
Prepared by	I D Isherwood
Date prepared	24 January 2018
Client

Report Following Concrete Testing

Knighthood Point
The Quarterdeck
London
E14 8SR

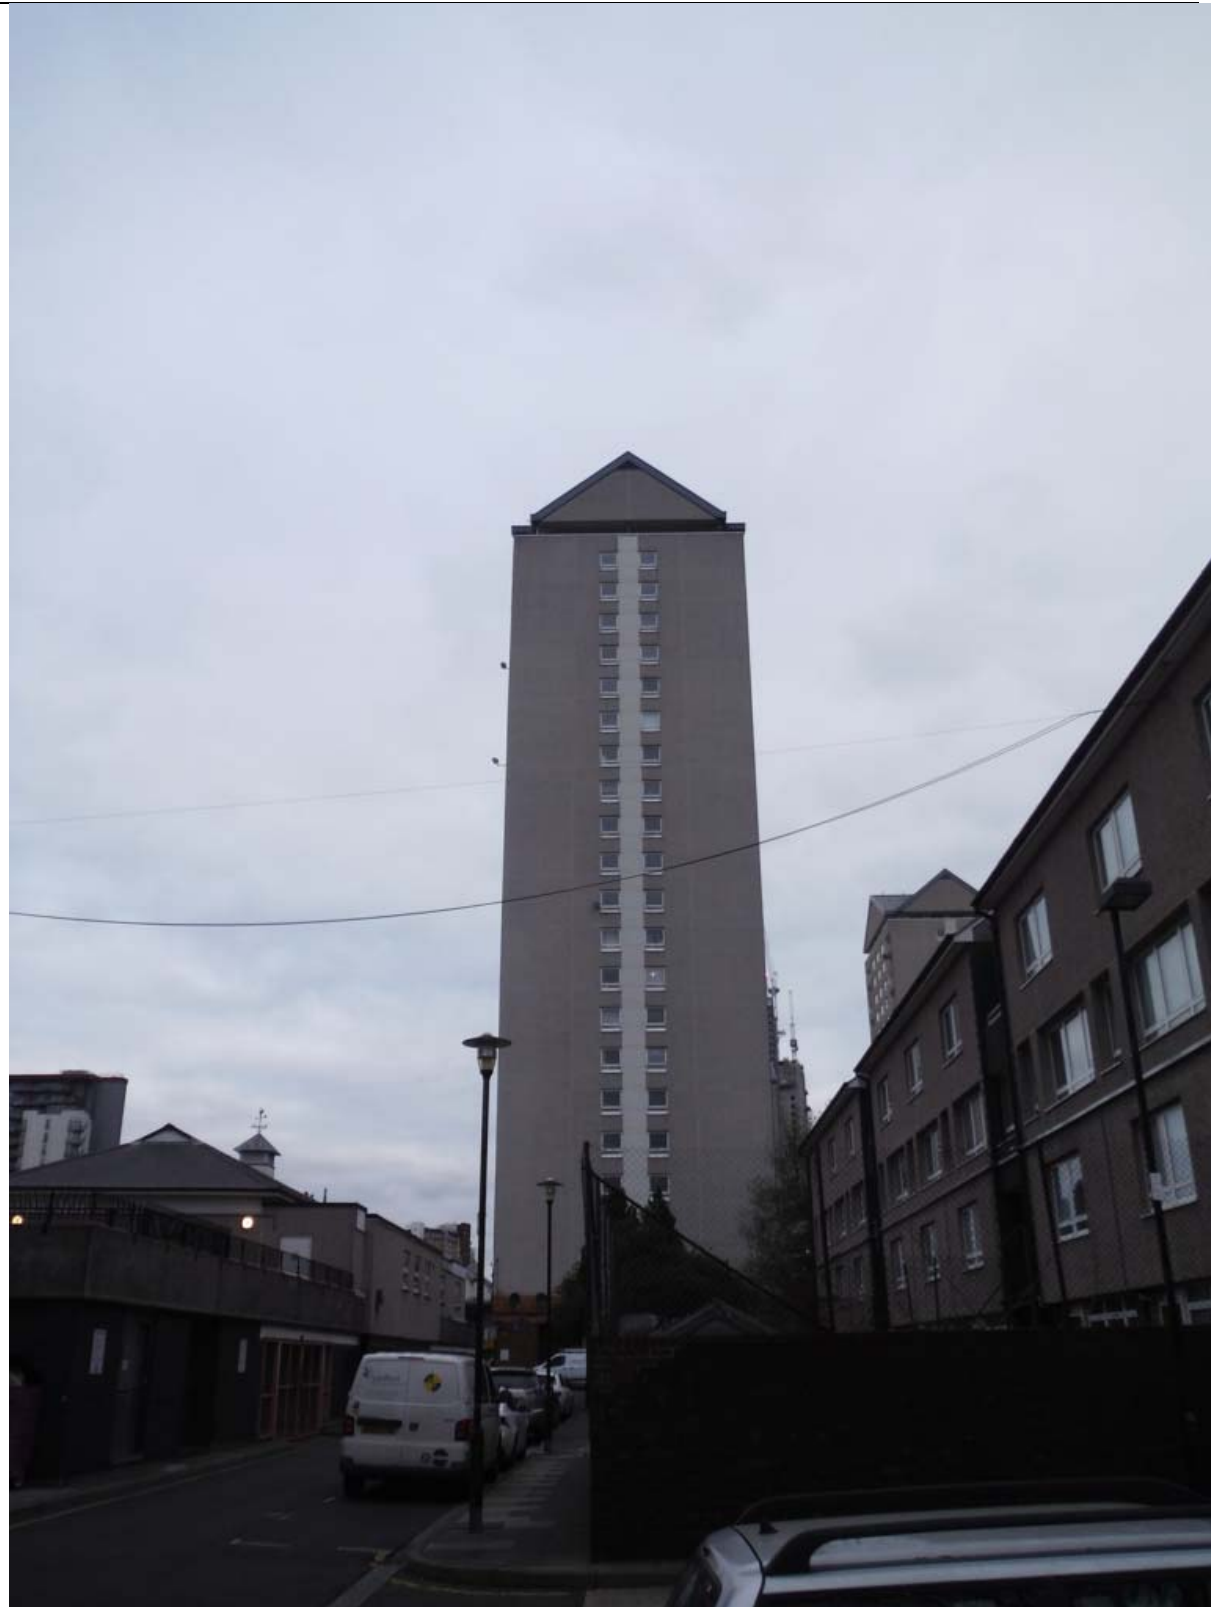
3.4) The block is of similar age and design to Bowsprit Point. It is presumed the external render is similar to Bowsprit Point with render on mineral wool which is fixed directly to the original concrete substrate with no formed void. Due to the render it is not possible to comment on the general condition of the external frame or cladding elements.

1) General view showing similar design and render to Bowsprit Point, Midship Point and Topmast Point.

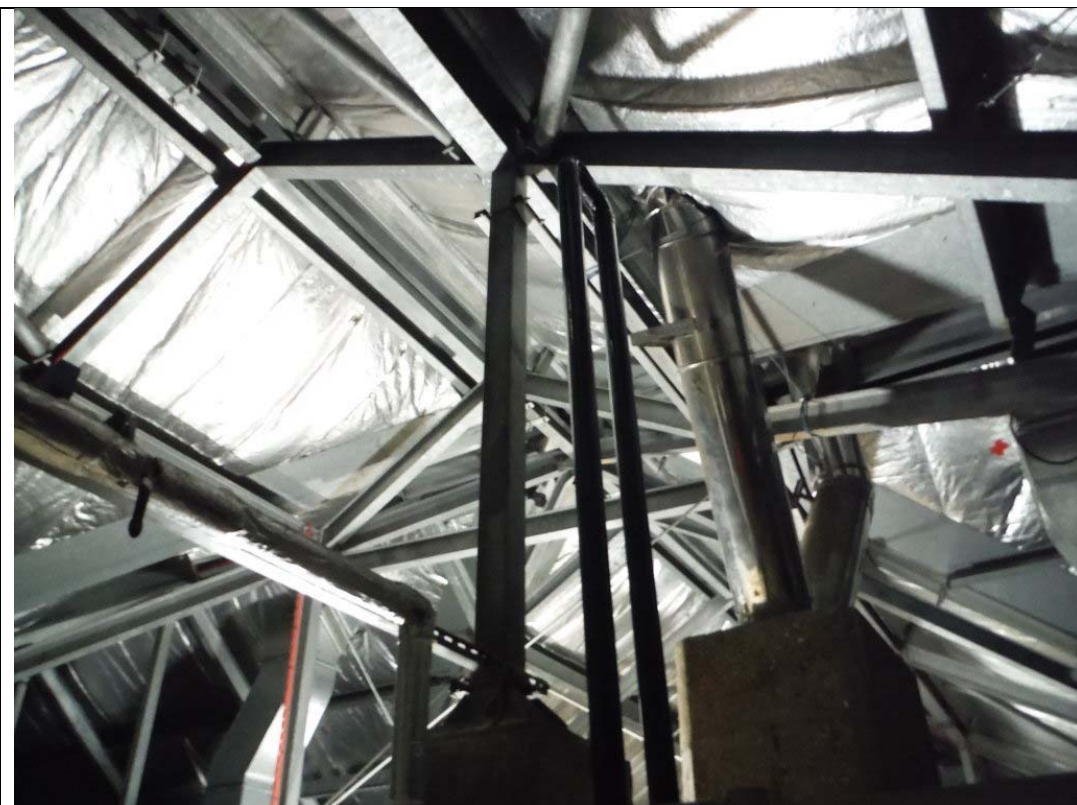
3.5) Concrete roof members including plant room walls etc. are over-clad by a pitched metal framed roof structure.

2) Internal view of pitched metal frame roof. Similar detail as other “Point” blocks.

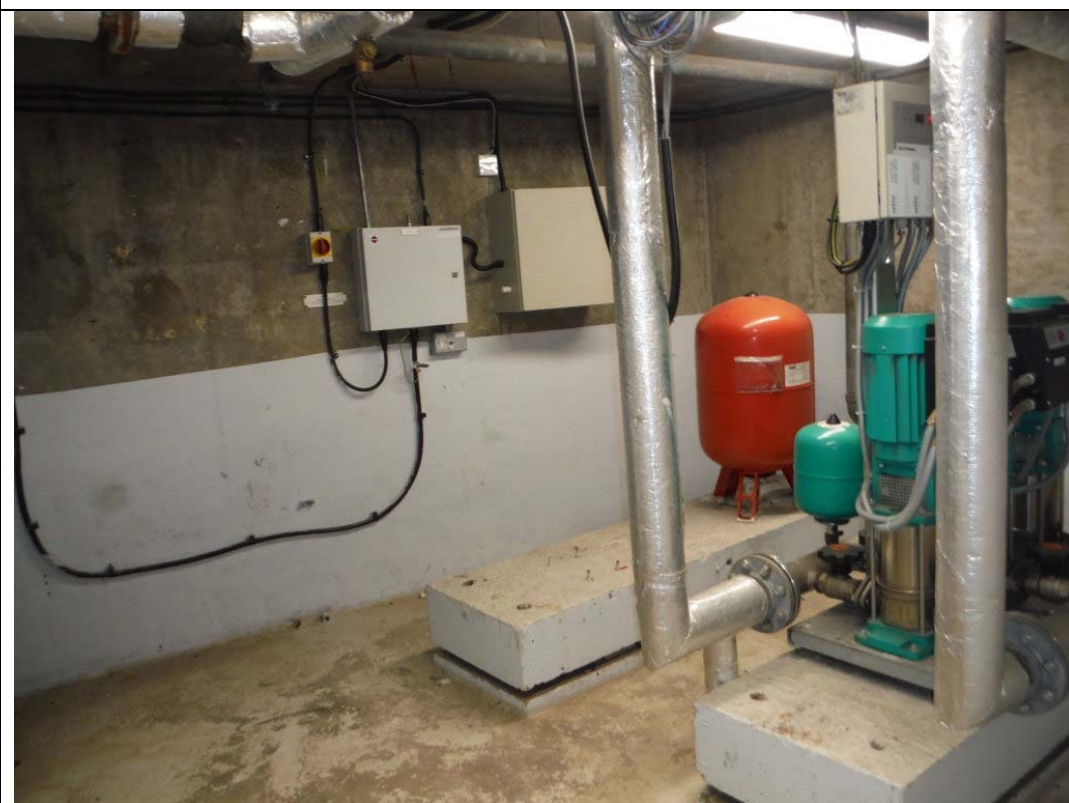
3) Apparent in-situ concrete to plant room

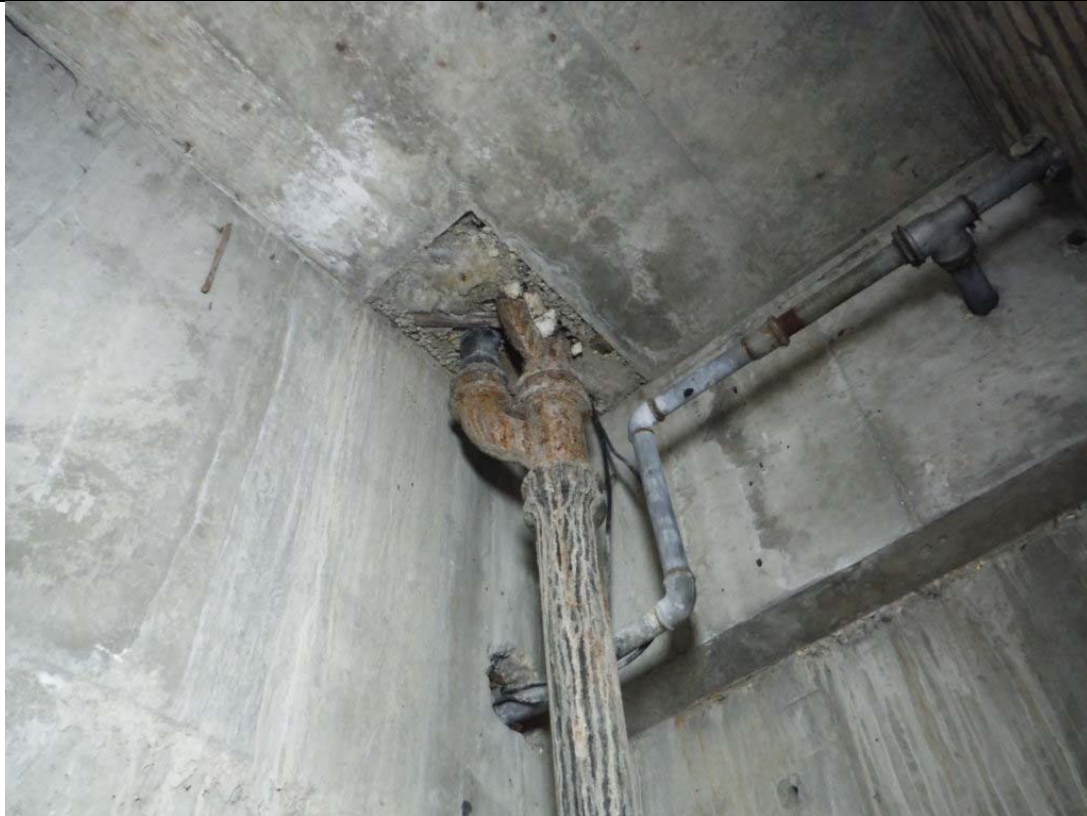
4) Apparent in-situ concrete to tank room floor and walls

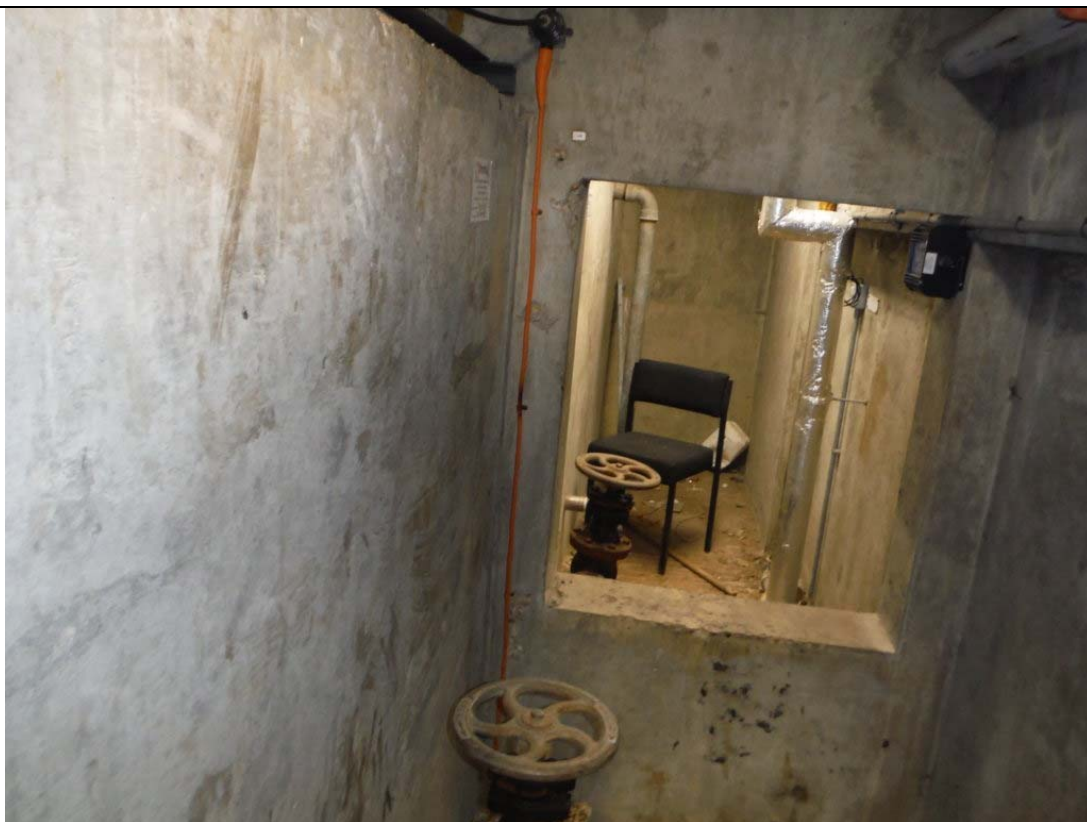
5) Apparent in-situ concrete to tank room floor and walls
