STRUCTURAL CONDITION INSPECTION REPORT
INCORPORATING LIMITED INTRUSIVE INVESTIGATION
AT
MIDSHIP POINT
THE QUARTERDECK
LONDON E14 8SW

Project Number	6627
Document Ref:	D009-A
Revision	A
Prepared by	I D Isherwood
Date prepared	24 January 2018
Client

Report Following Concrete Testing

Midship Point
The Quarterdeck
London
E14 8SW

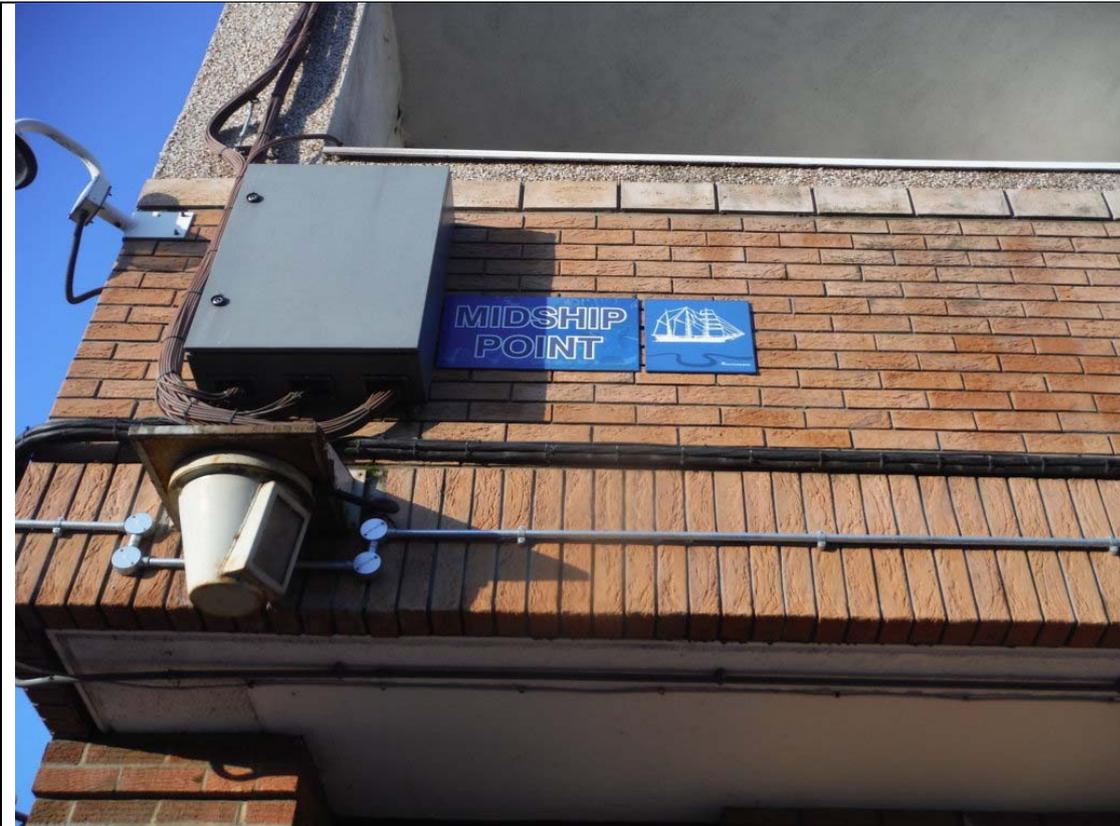
1) general view of external façade at 1st floor level is similar to other “Point” blocks.

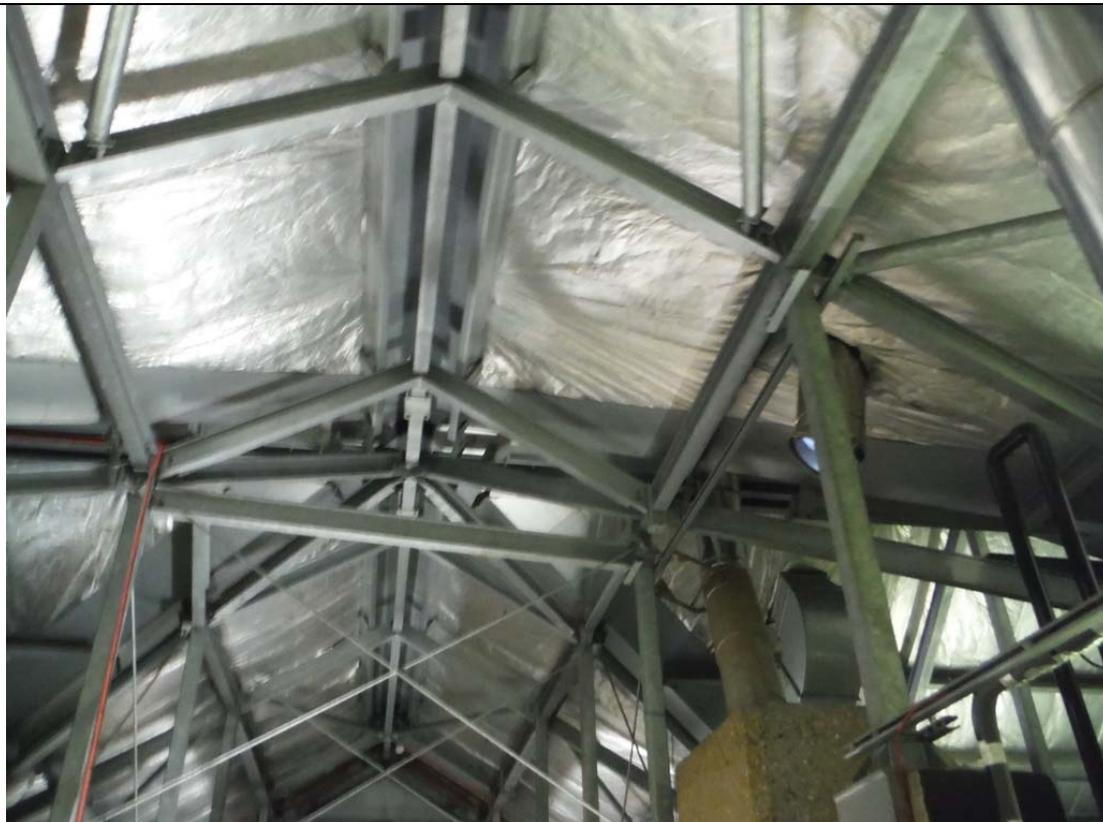
2) internal view of metal framed pitched roof similar to other “Point” blocks

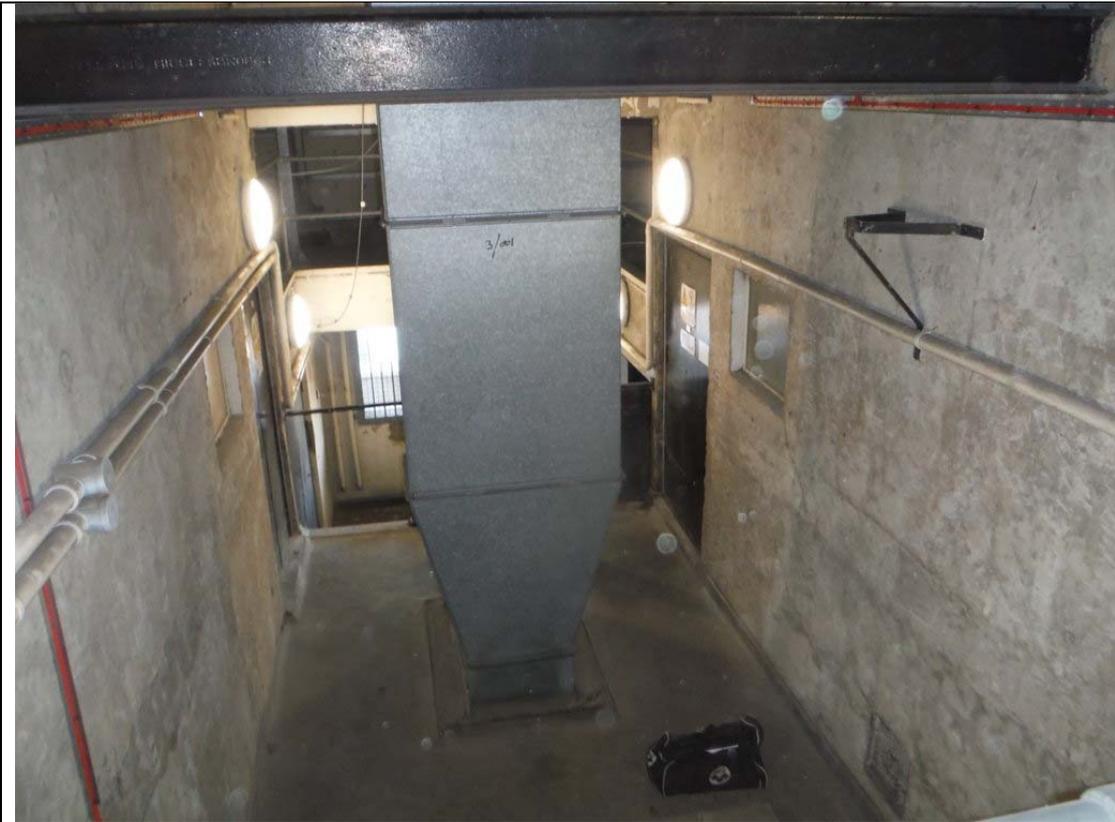
3) Exposed walls at roof level apparently in-situ concrete.

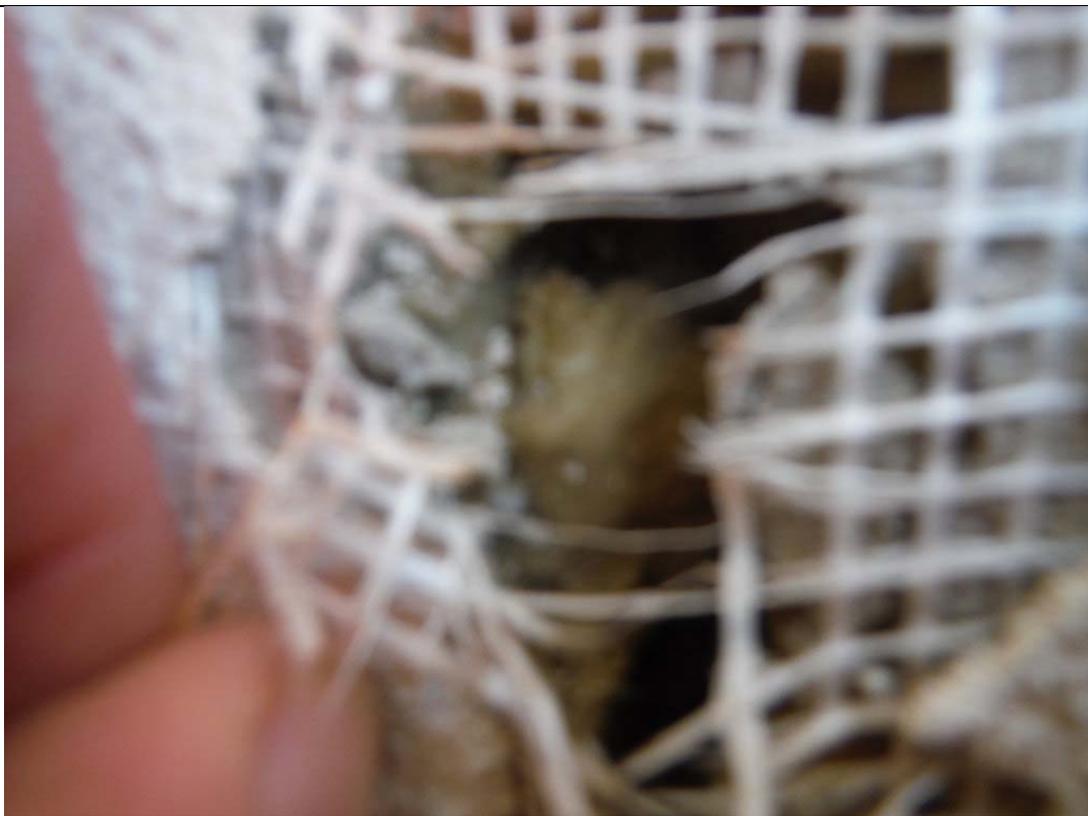
3.4) The block is rendered externally in similar style to Bowsprit Point. It is presumed that the render is on mineral wool which is fixed directly to the original concrete substrate with no formed void in similar style to Bowsprit Point. Due to the render it is not possible to comment on the general condition of the external frame or cladding elements.

4) mineral wool insulation behind nylon reinforced render

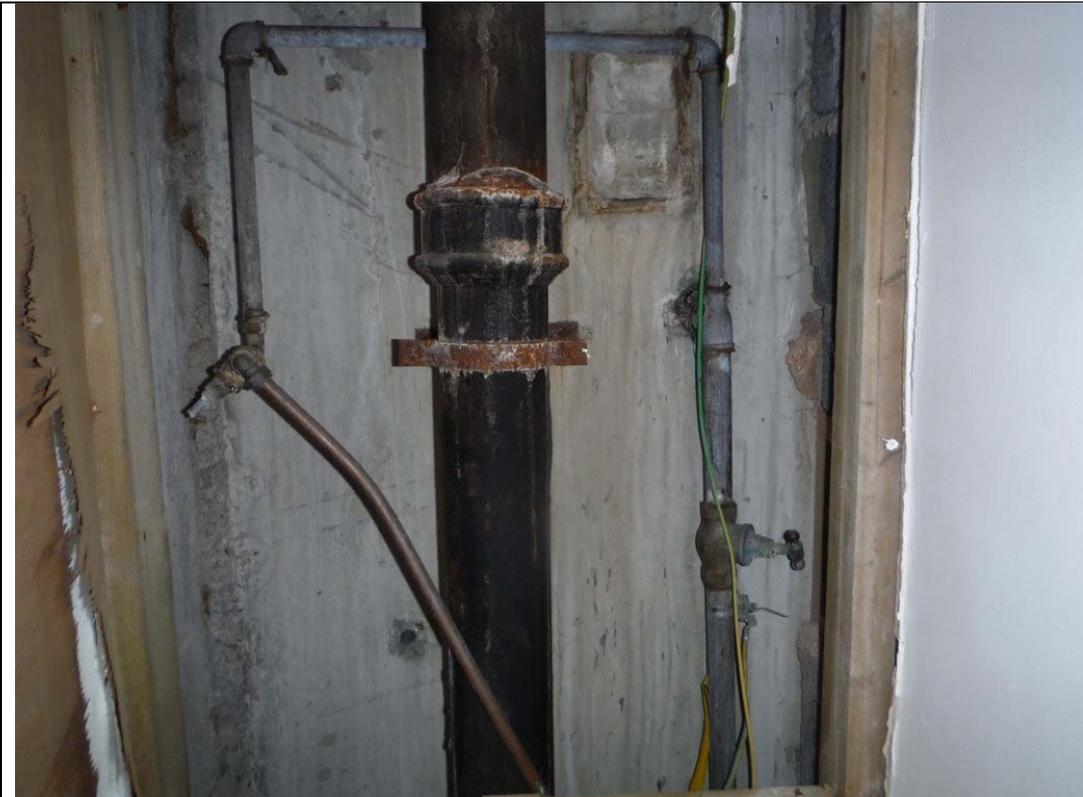
5) apparent in-situ concrete internal wall to drainage riser

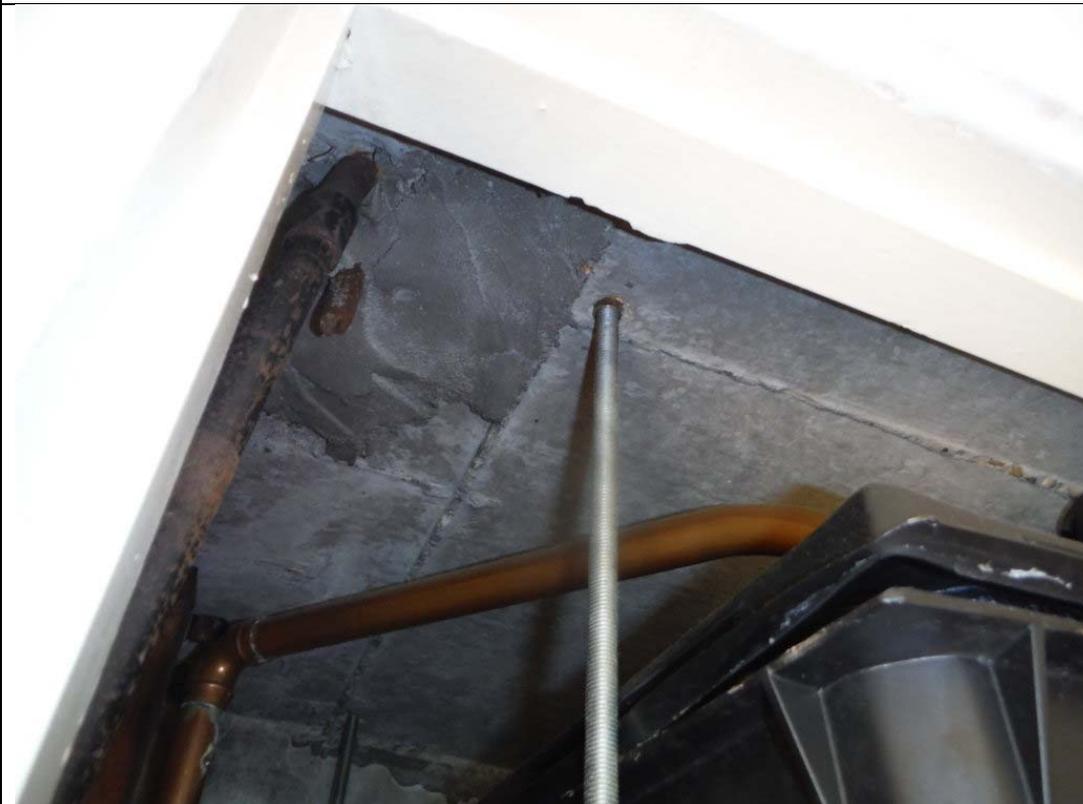
6) Apparent in-situ concrete to upper floor slab

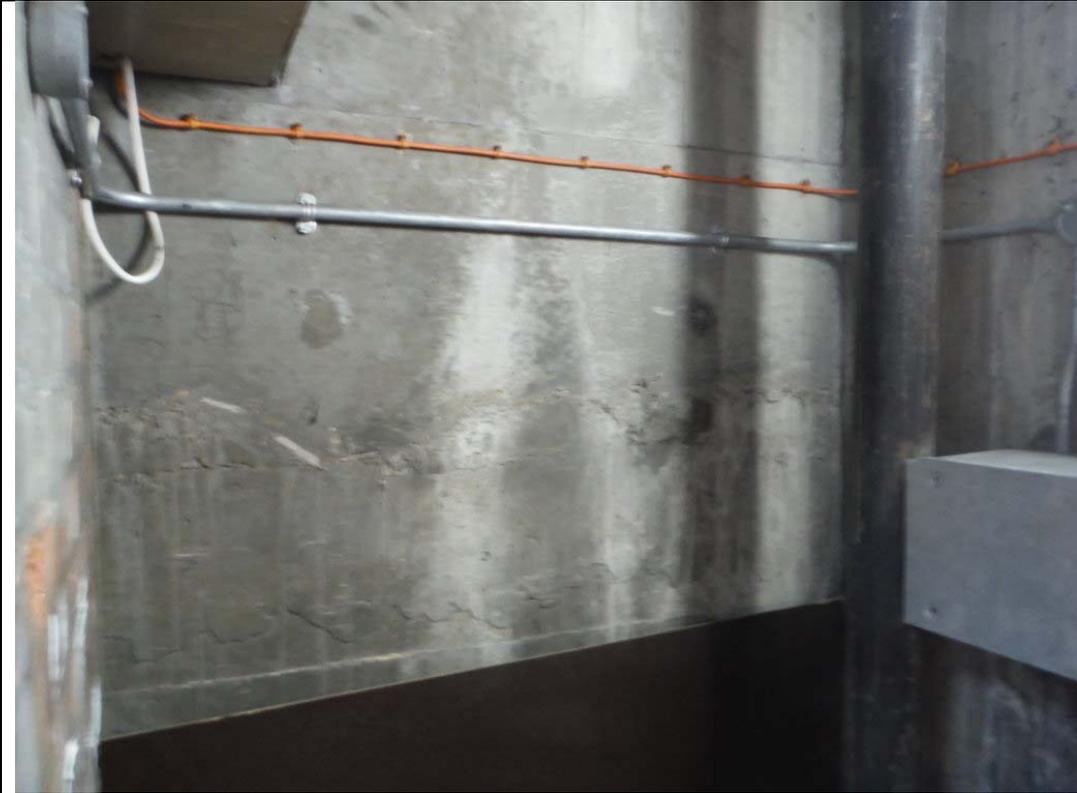
7) apparent in-situ concrete to plant room

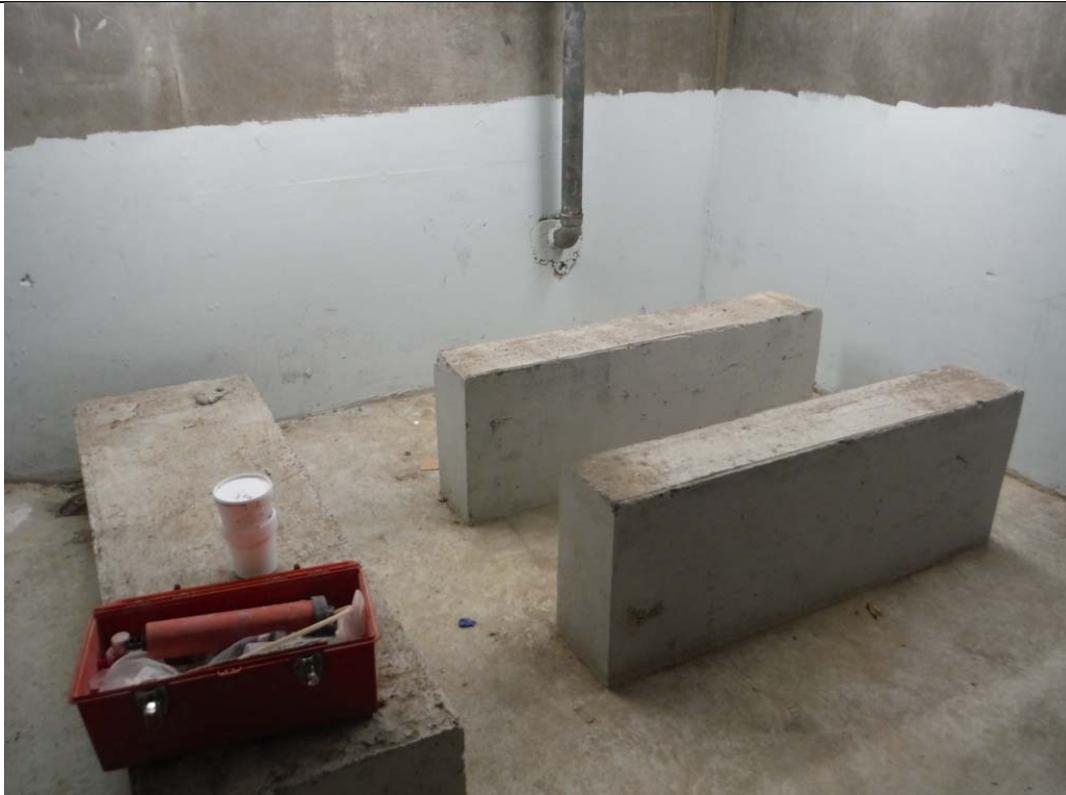
3.6.1) There was hairline cracking noted to external walls within the basement tank room. This is not considered to be of structural significance at present however it may be prudent to consider monitoring future movement of the cracks.

8) apparent in-situ concrete to tank room
