STRUCTURAL CONDITION INSPECTION REPORT
INCORPORATING LIMITED INTRUSIVE INVESTIGATION
AT
TOPMAST POINT
THE QUARTERDECK
LONDON E14 8SL

Project Number	662710
Document Ref:	D010-A
Revision	A
Prepared by	I D Isherwood
Date prepared	24 January 2018
Client

Report Following Concrete Testing

Topmast Point
The Quarterdeck
London
E14 8SL

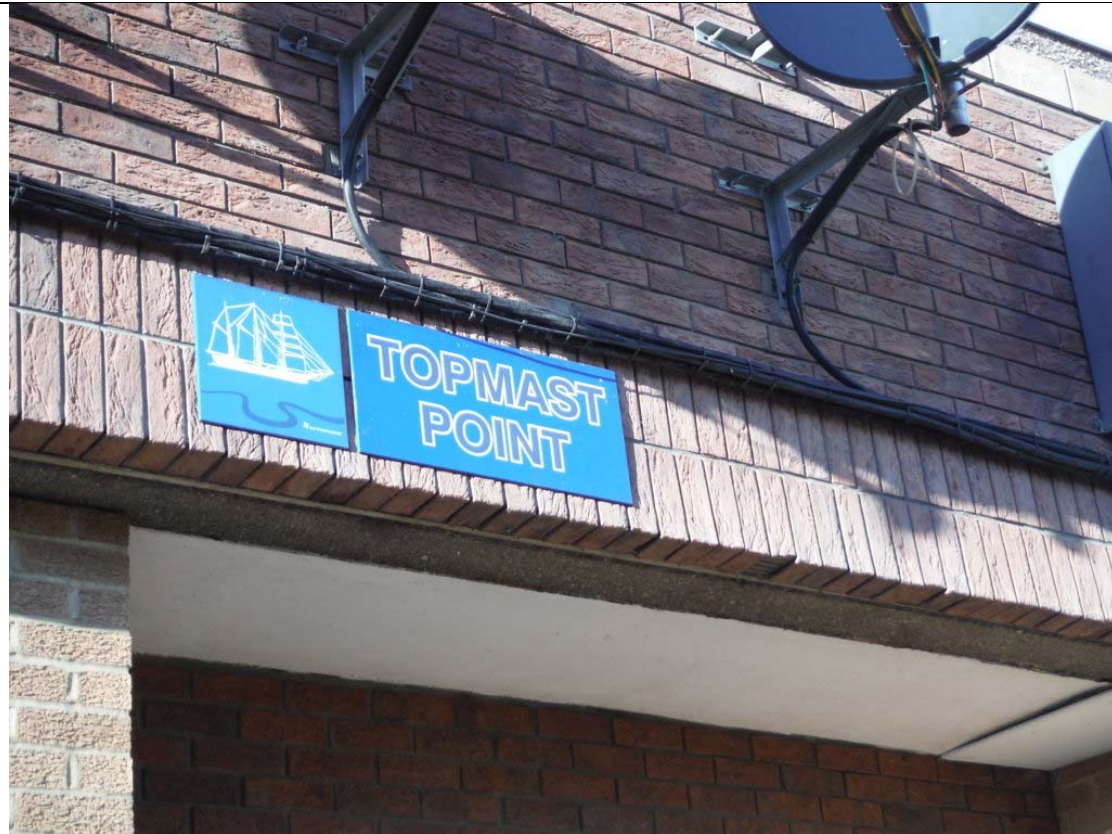
3.5) The block is of similar age and design to the other “Point” blocks. It is presumed the external render is similar to Bowsprit Point with render on mineral wool which is fixed directly to the original concrete substrate with no formed void. Due to the render it is not possible to comment on the general condition of the external frame or cladding elements.

1) general layout and external finishes similar to the other “Point” blocks

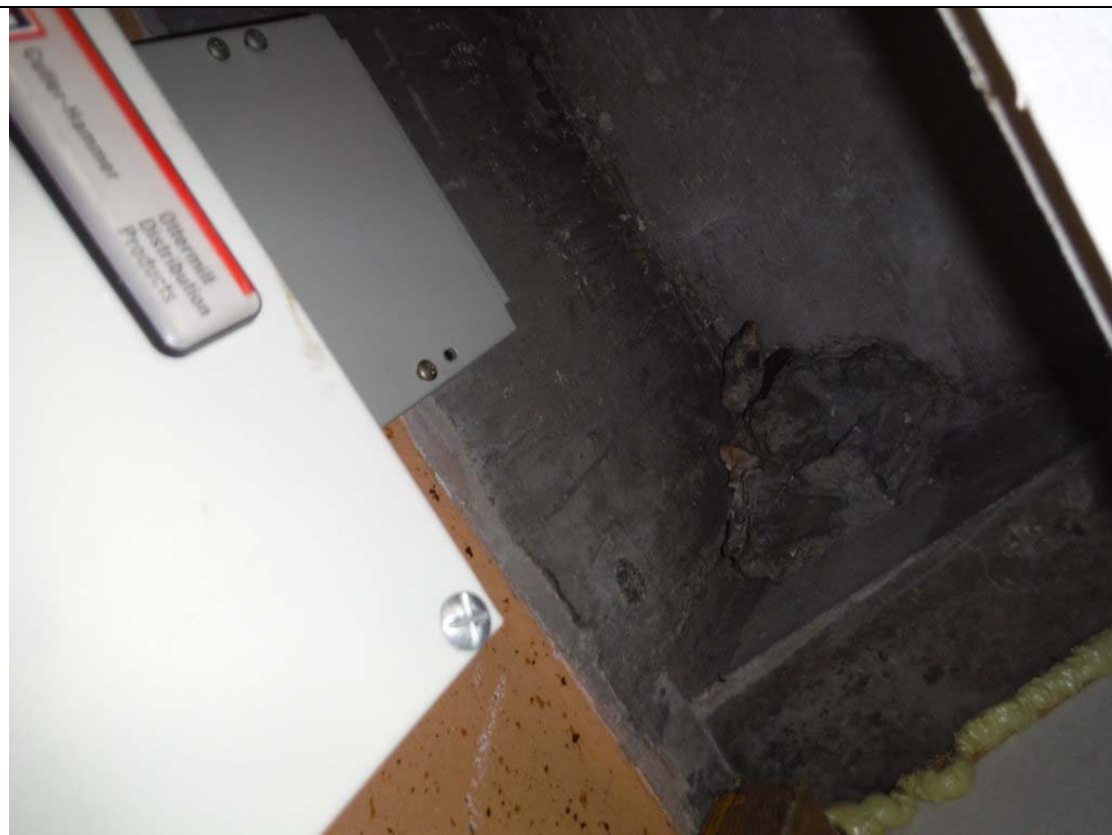
3.7) Internal concrete elements appeared to be cast in-situ (where seen) and in fair condition. Please note that no void units were available for access. The ground and basement plantrooms were also not accessible with standard FB keys.

2) Service riser slab and wall of in-situ concrete

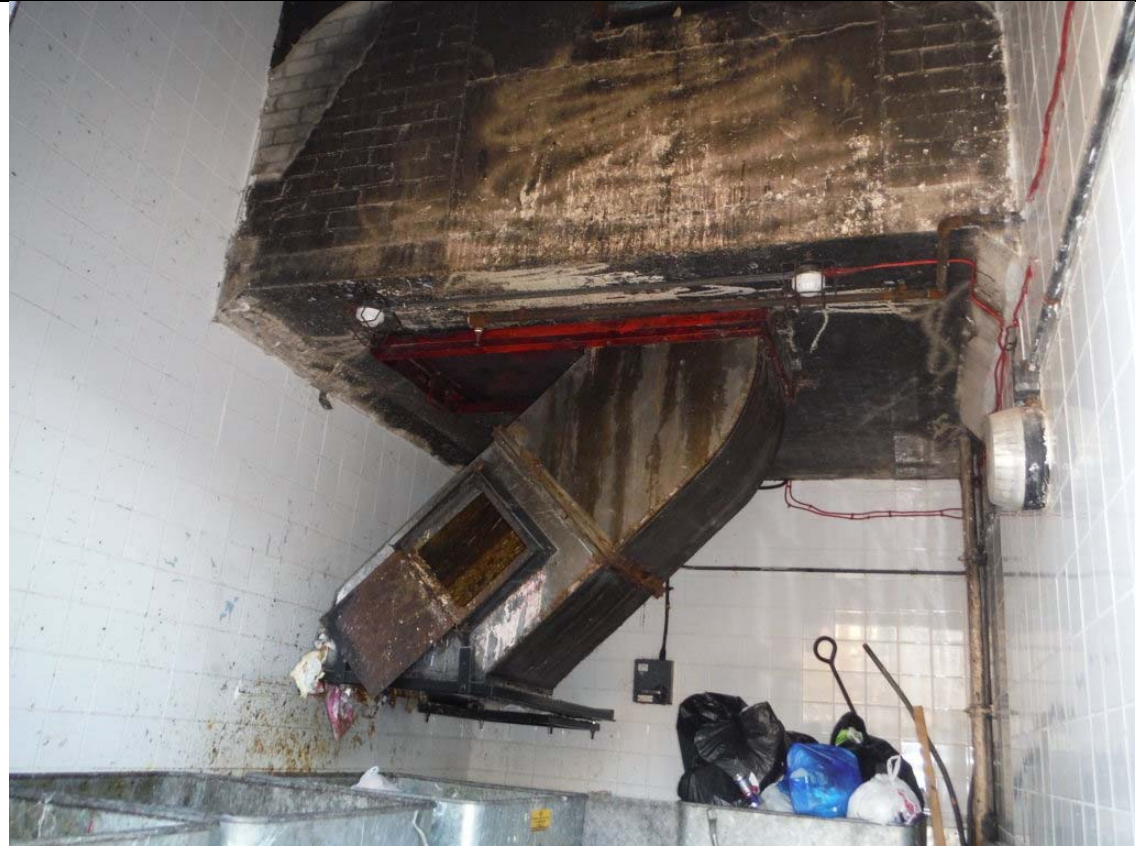
3) Bin store wall of in-situ concrete
