## **Condition Report of the Building Services Installation.**

### **Kedge House**

**Prepared by MCCE on behalf of Hunter & Partners for One Housing**

**February 2018**

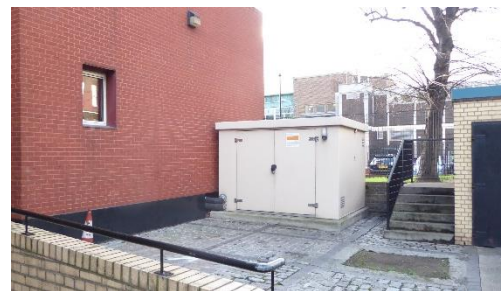
Plate Heat Exchange Room

Access was not available to the Barkantine plate heat exchange plant room and so the condition of the circulation pumps could not be assessed.

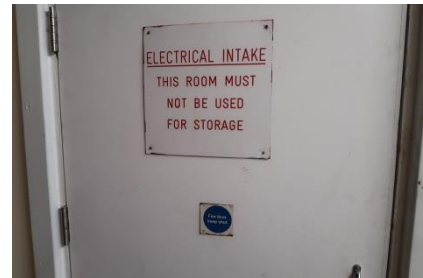
The incoming supply enters the building at the ground floor intake room access from the internal of the building.

Access to the Intake room was not gained.

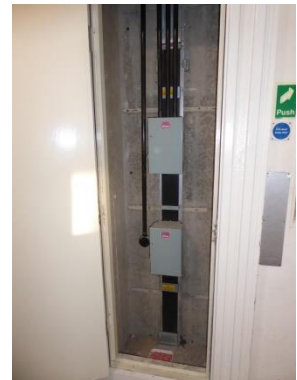
From the main intake room the rising bus bars are fed. These rise through the building in the services risers and have tap offs on each level to serve the four dwellings located on the floor.

The rising bus bar system is obsolete as the manufacturer is no longer in business and spares may be difficult to obtain.

The electrical services appear to be suitably sized for the buildings load. There were no signs of overloading to any of the switchgear that was inspected and the Busbar system appeared in good condition.

It is likely that the Busbar system will need replacement and the lateral supplies to the dwellings appear to be as originally installed. These should only be carried out in conjunction with works within the dwellings.

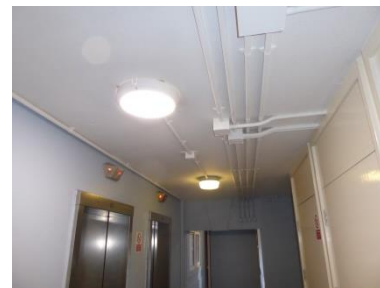
The lighting to the main communal areas has been replaced with fluorescent lighting with some newer LED fittings which are also used for emergency lighting.

Coverage through all communal areas is more than adequate with very good visual uniformity.

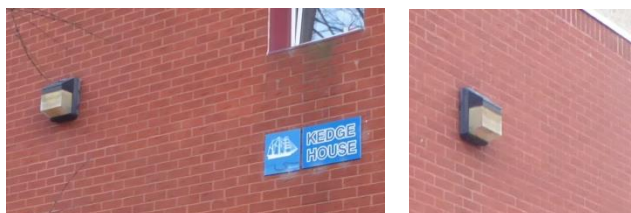
External lighting appears very dated with the lenses “yellowing” due to age. The fittings appear to be approaching the end of their economic life expectancy.

The light fittings are estimated to be in excess of 15 years old with an anticipated life of 15 years. It was unclear from the survey if the wiring had been replaced with the fittings and so the budget below allows for a complete system replacement in year 4.

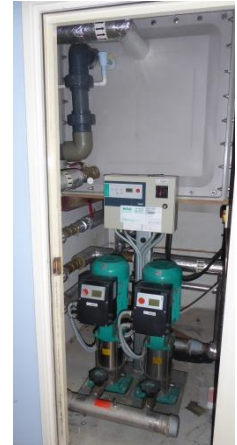
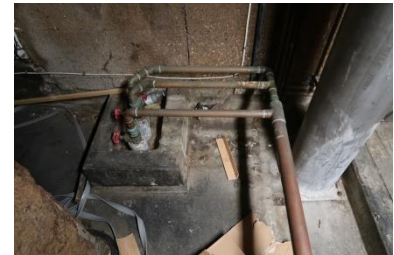
At roof level the pipework is formed in copper. This may be local to the tank bypass area.

For the purposes of this report we have taken the rising water mains to be formed in Galvanised Steel

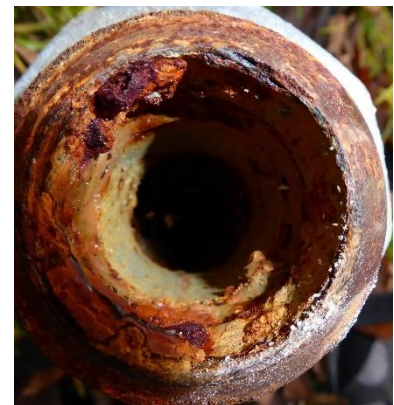
It is reasonable to expect the internal surfaces to be failing and any internal corrosion will start a snowball effect and cause the pipework to contaminate the pipework and water supply at an increasing rate.

The Photo is of pipework from the building MCCE are currently working on to replace the water Services pipework. This building is within the Tower Hamlets area and is of identical layout and age.

This budget covers the complete renewal of the water services pipework system from ground to roof level serving. Before this work is carried out a sample of the pipework should be taken to confirm the expected condition of the pipework system.

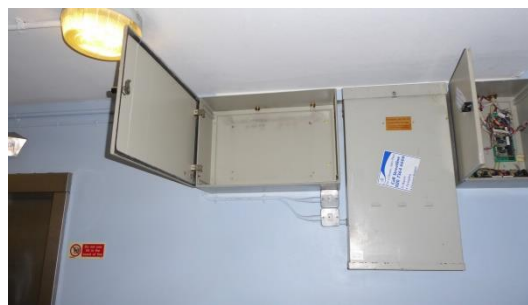
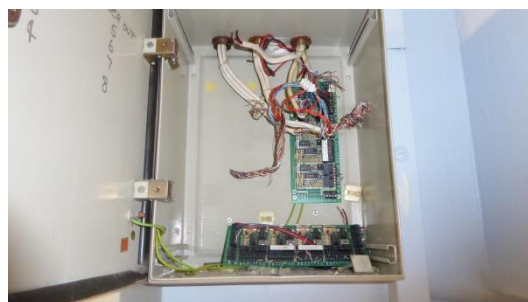
The system has a significant number of components missing and disconnected and it is possible that not all features are functioning.

The system has exceeded its anticipated life expectancy of 15-20 years and has been budgeted for complete replacement.

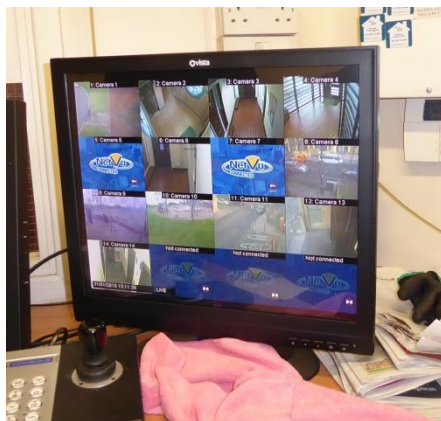
CCTV Monitor.

The images are of reasonable quality internally but the external cameras had poor resolution. There are 2 cameras non-operational out of the 14 on the system.

Within the budget we have allowed for the replacement of the system in year 5 although there will almost certainly be occasional failures of cameras requiring replacement.

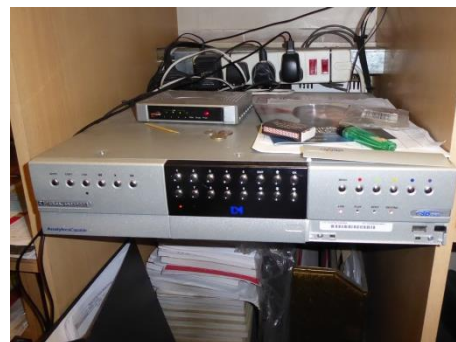
CCTV Recorder.

The system is housed in the concierge's office and is estimated to have been installed in 2010. There are a number of cameras visible that appear non-operational. These may from a previous installation.
