Condition Report of the Building Services Installation.

Kelson House

Prepared by MCCE on behalf of Hunter & Partners for One Housing

February 2018

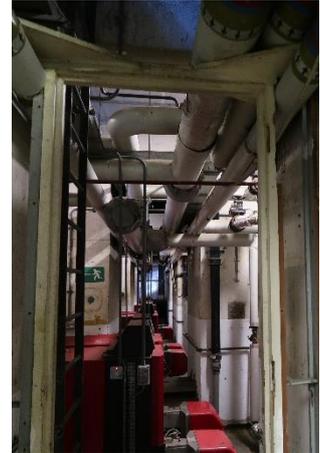
Boiler Plant

The main boilers were manufactured in 2006 and much of the central plant installation appeared to be of this age. The pipework system is much older

The central boiler plant was installed in 2006 and has some 8 years remaining on its anticipated economic life expectancy. Our budget allows for the replacement in year 8 however, this may be brought forward should a decision to replace the system is made.

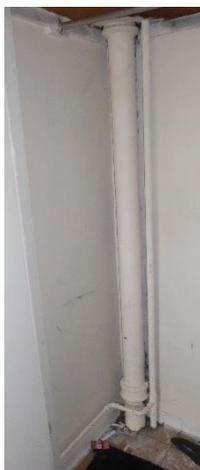
Single Pipe Riser
Next to Soil Pipe

Radiator valve and
pipework into adjacent
dwelling through wall.

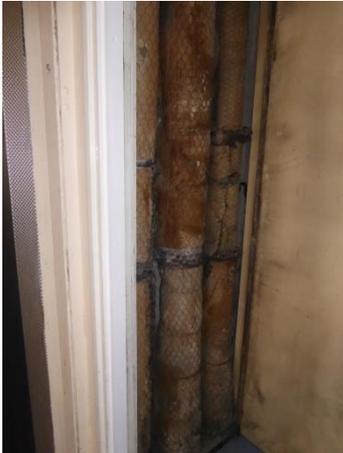
Pipework Riser in communal Area

The pipework risers are mostly within the dwellings with some of the main pipework in service risers in the communal areas. The pipework was in reasonable external condition for its age but this is estimated at some 48 years.

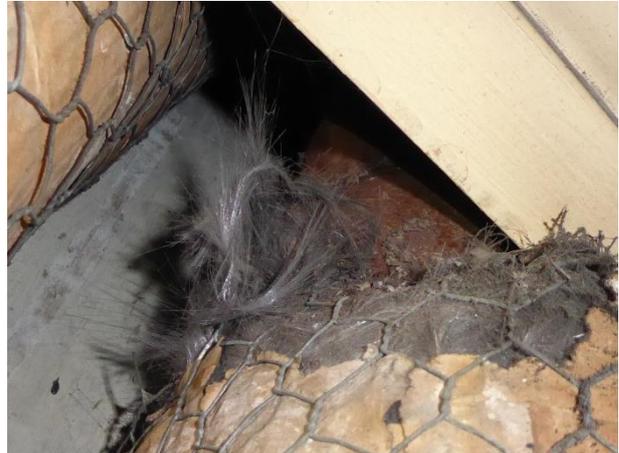
Pipework Corrosion

The heating distribution pipework was in poor condition with external pipework corrosion clearly visible. CIBSE Guide M states that the life expectancy for steel pipework is 25 years and we believe the system to be up to the age of the building circa 48 years.

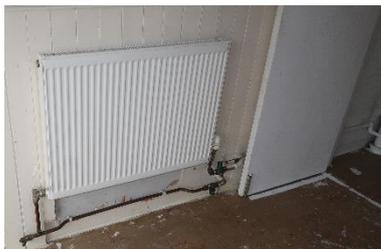
The dwellings appear to have had the radiators replaced within the last 10 years but the pipework appears to be as old as the distribution pipework.

Typical radiator and pipework system with flat No.s 16 & 51.

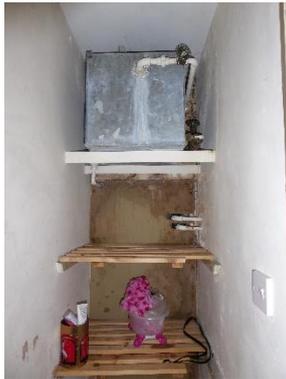
Cold Feed
Tank in Flat 16

Within the dwellings are individual water tanks serving the HWS cylinders and cold taps to the WC and Bathrooms. Of the two apartments inspected one had a tank replace and the other had the original galvanised steel tank. Based on this an allowance for 50% of the tanks to be replaced has been made.

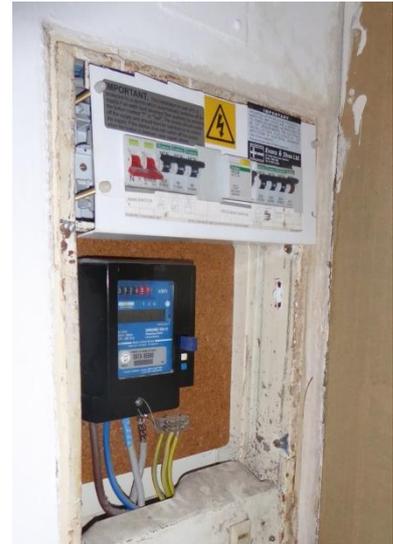
The board has been cut away at both ends to the rear to fit the contours of the space. The two faces are held together by metal screws.

The single largest non-compliant area is the dwelling consumer units. These as shown in section 3.2.4 have been cut to make fit in the old meter cupboard. In our opinion these should be immediately removed and replaced.

This unit could fit above the recessed space or the area could be expanded to accept the larger consumer unit.

The budget allows for the replacement of the consumer unit to all dwellings relocating new units to a suitable location without the need for modification. As this is essential work we have shown this for all dwellings including leaseholders.

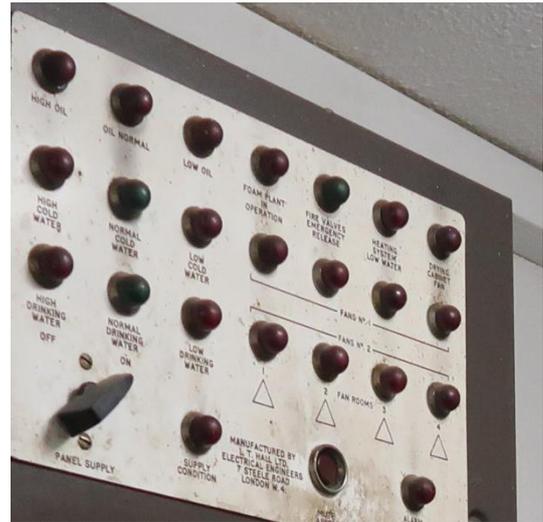
The central ventilation system extracts air from the bathrooms and WC's. Grilles and a redundant warning panel were located during the survey but the central plant was not located.

Redundant Central Plant Alarm Panel Including Extract Fan System.

This budget covers replacement of the Extract fan units in year 6. However the fans were not located and it is unclear if this system is still active or the actual condition of the fans which may vary the timing of the replacement.

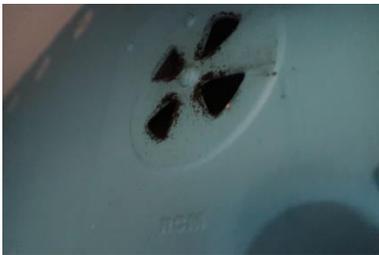
WC Vent in Flat 16

The grilles are ducted to a builderswork shafts which is routed to all levels adjacent to the bathrooms. From the shaft a duct serves the Bathroom and WC area with grilles cut directly into the shaft.

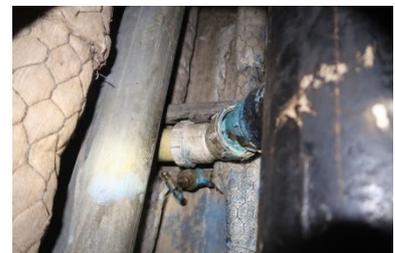
From the survey of the two dwellings No.16 & 51 and MCCES experience within similar blocks with Cast Iron soil stacks, leakages are caused by the poor connection rather than the main soil stack failures.

The photo shows a typical new connection to the stack from the Kitchen using a white compression fitting onto the original copper joining the stack from a yellowing waste pipe. The fittings have been mastic sealed to reduce leakage as the fittings do not connect "square".

The works below is an allowance to enter each dwelling and replace the drainage connection to the main soil stack with a connection that is designed to be used with a Cast Iron Stack. The connection will be linked to the resident's system external to the riser allowing the resident make modifications in the future without entering the riser.

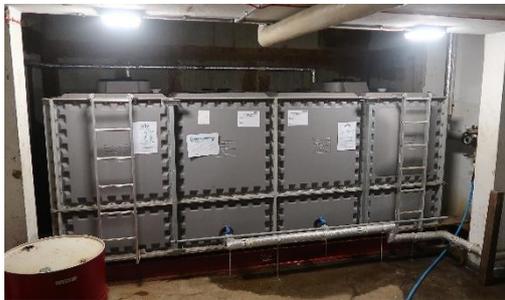
Main Cold Water Storage tank –
This tank is a split tank to allow for maintenance whilst maintaining the service.

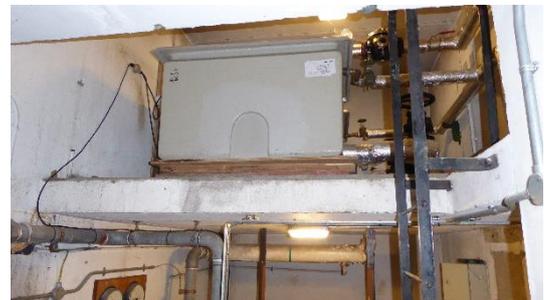
Drinking Water Storage tanks –
There are 2 tanks located over the booster set.

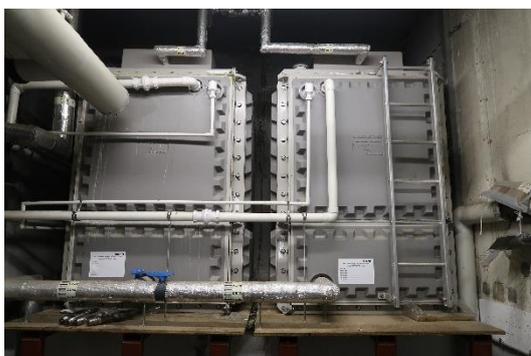
Roof Plant Area Cold
Water Storage tanks.
There are 4 of these
within the plant area.

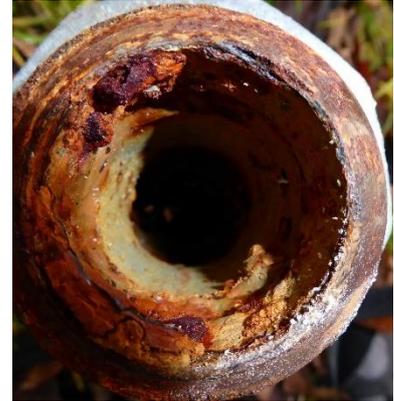
The internal condition of the pipework cannot be confirmed without cutting a section out for examination. However, galvanised pipework does corrode over time and the pipework is in excess of 45 years old. The CIBSE Guide M states that Galvanised pipework has a life expectancy of 35 years.

It is reasonable to expect the internal surfaces to be failing and any internal corrosion will start a snowball effect and cause the pipework to contaminate the pipework and water supply at an increasing rate.

The photo is of pipework from the building MCCE are currently working on to replace the water Services pipework. This building is within the Tower Hamlets area and is of a similar age to Kelson House.

This budget covers the complete renewal of the water services pipework system from ground to roof level serving. Before this work is carried out a sample of the pipework should be taken to confirm the expected condition of the pipework system. This can easily be carried out within the dwellings during a tank replacement but a large diameter section of pipe should also be cut for inspection.

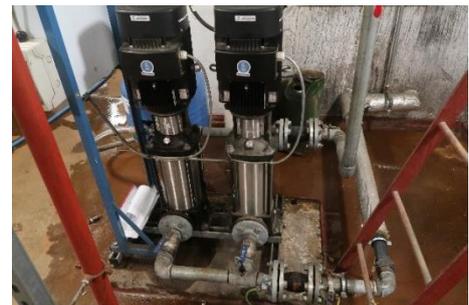
The CWDS booster pumps were installed in 2011 with the storage tanks and appear to be in good operational condition.

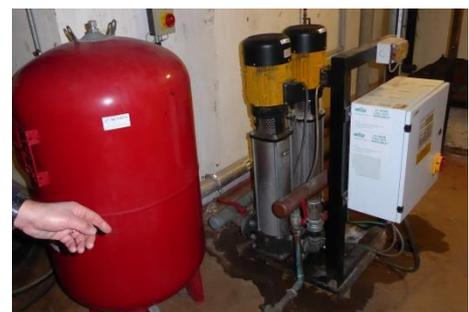
The Drinking Water booster pumps were installed in 2005 with the storage tanks and appear to be in good operational condition.

The individual pumps can be replaced on an ad-hoc basis but the set will eventually require complete replacement.

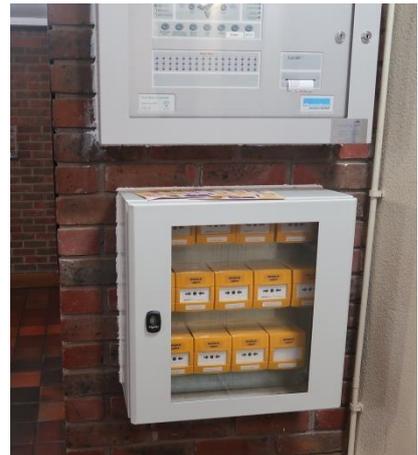
The system is dated and appears to be in excess of 15 years old.

It is unclear if the opening vents still operate. One of the mechanisms inspected kept the window open.

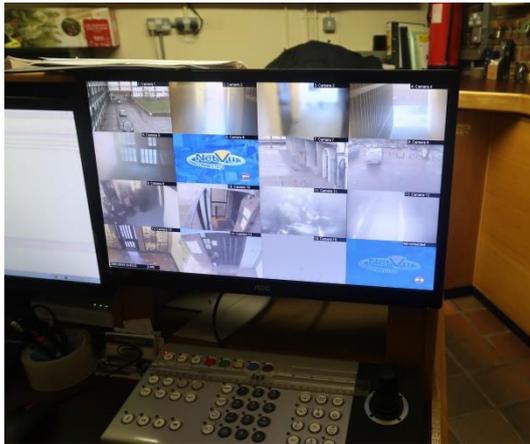
CCTV Monitor.

The system is housed in the concierge's office and is estimated to have been installed in 2010 although there are a number of components that have been replaced. There is only one of the cameras visible that appear non-operational.

The images are of low quality but the system appears to have some cameras non-operational.

Within the budget we have allowed for the replacement of the system in year 5 although it may be some consideration should be given to the quality of the images from the existing cameras and potentially have an upgraded system earlier than a system failure.
