STRUCTURAL CONDITION INSPECTION REPORT
INCORPORATING LIMITED INTRUSIVE INVESTIGATION
AT
BOWSPRIT POINT
167 WESTFERRY ROAD
LONDON E14 8NU

Project Number	6627
Document Ref:	D007-A
Revision	A
Prepared by	I D Isherwood
Date prepared	24 January 2018
Client

Title: **BOWSPRIT POINT – 167 WESTFERRY ROAD – LONDON E14 8NU**

Report Following Concrete Testing

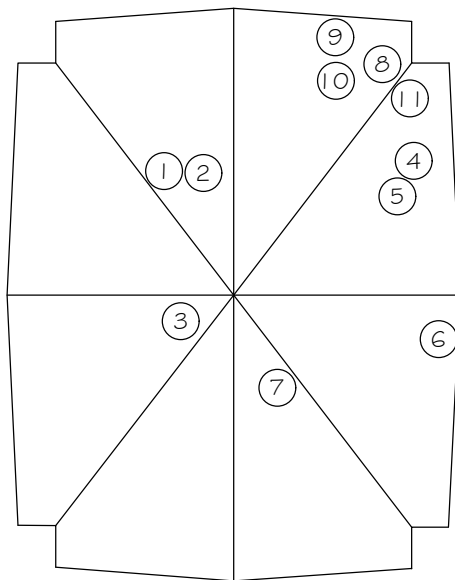
10. Appendix – Block Plans

BOWSPRIT POINT							
Sample	Floor	element	depth	cover	carbonation	chloride ion (by mass)	Comments
ref.			profile	depth	depth	presuming 14% OPC	
				(mm)	(mm)	(%)	
1	roof	lift motor room wall	bulk	45	5	0.07	covered by metal framed roof
2	roof	slab edge	bulk	25	10	0.10	covered by metal framed roof
3	roof	lower slab edge	bulk	20	10	0.06	covered by metal framed roof
4	19	party wall	bulk	30	5	0.14	S side, flat 74
5	19	W.C. wall	bulk	44	10	0.03	drainage riser, internal wall
6	20	stairwell wall	bulk	60	5	0.05	painted
7	ground	internal wall	bulk	35	10	0.11	exposed
8	ground	plant room column	bulk	65	10	0.01	exposed
9	ground	plant room end wall	bulk	60	10	0.03	end wall clad externally in brickwork
10	ground	plant room pier	bulk	25	10	0.05	exposed
11	ground	plant room soffit	bulk	25	10	0.05	exposed
