STRUCTURAL CONDITION INSPECTION REPORT
INCORPORATING LIMITED INTRUSIVE INVESTIGATION
AT
KELSON HOUSE
STEWART STREET
LONDON E14 3JQ

Project Number	6627
Document Ref:	D013-A
Revision	A
Prepared by	I D Isherwood
Date prepared	24 January 2018
Client

Title: **KELSON HOUSE – STEWART STREET – LONDON E14 3JQ**

9. Appendix - Constructive Evaluation Report KELSON HOUSE

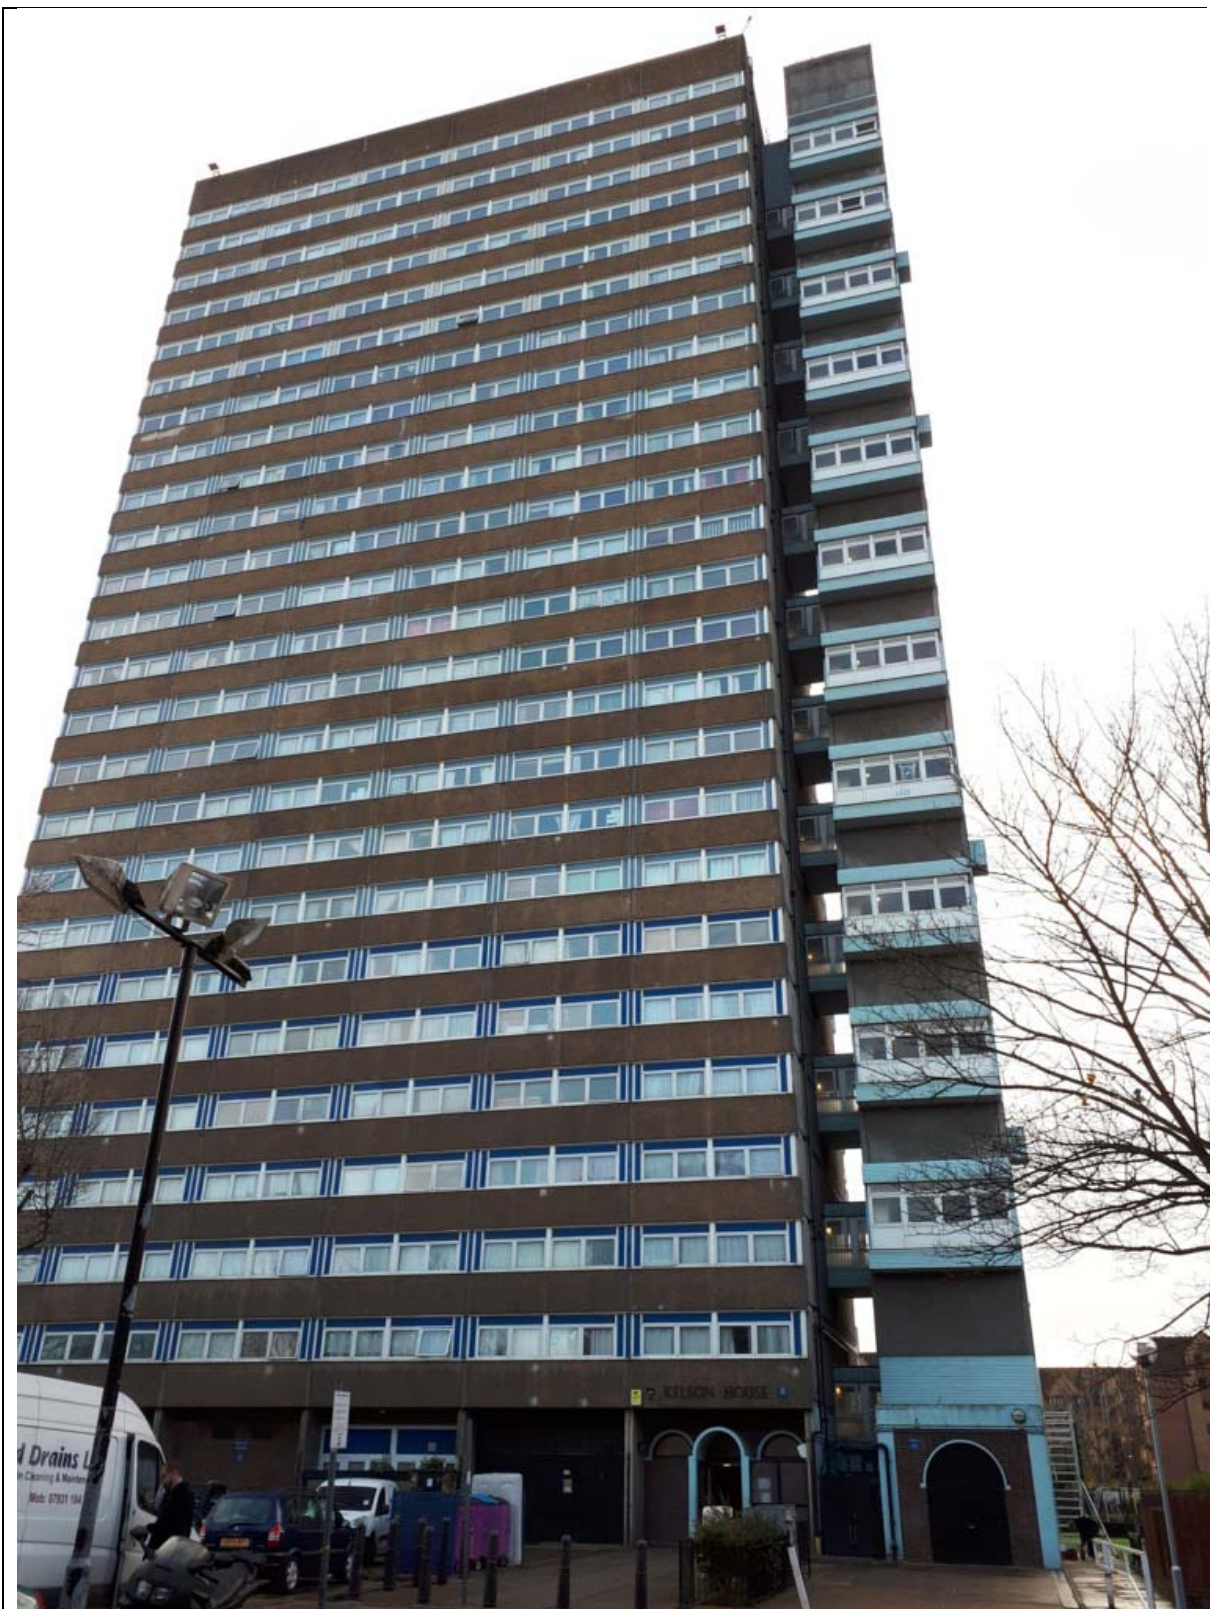
1) Kelson House main entrance, North side with lift core to right hand side.

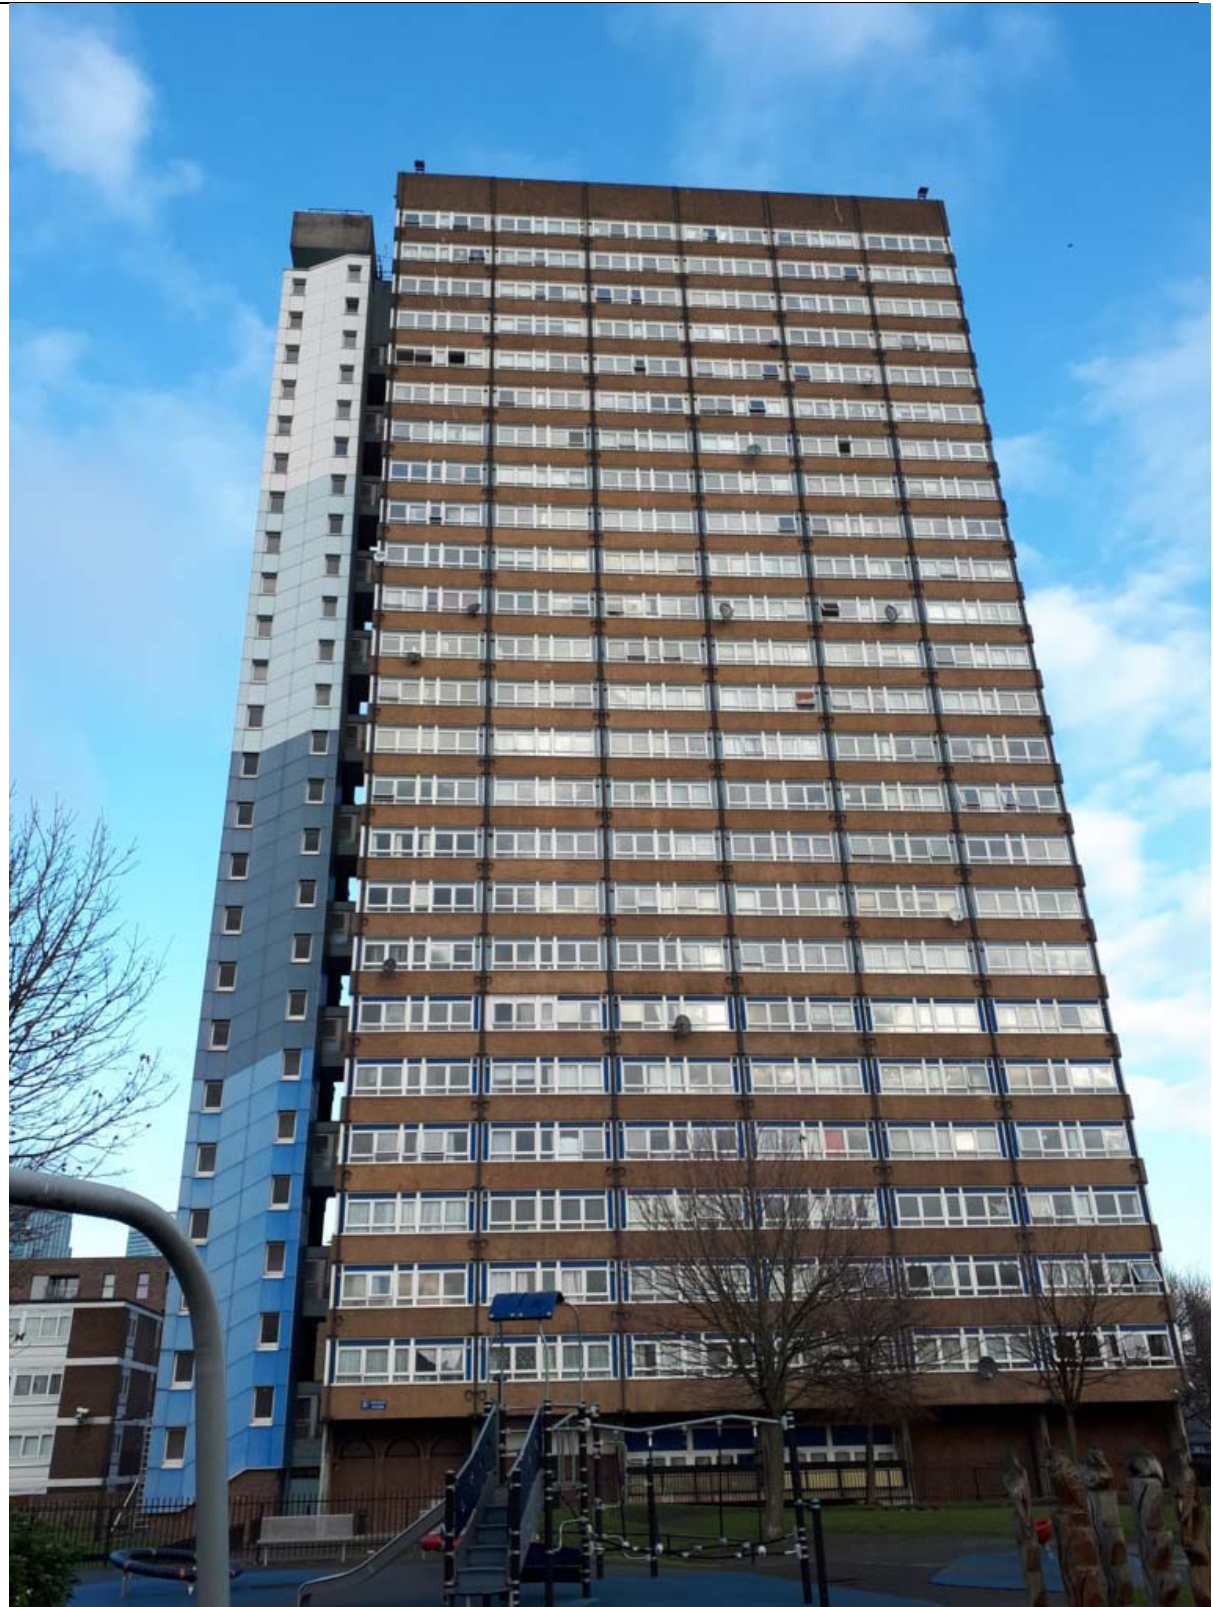
2) Kelson House South side. Lift core to the left

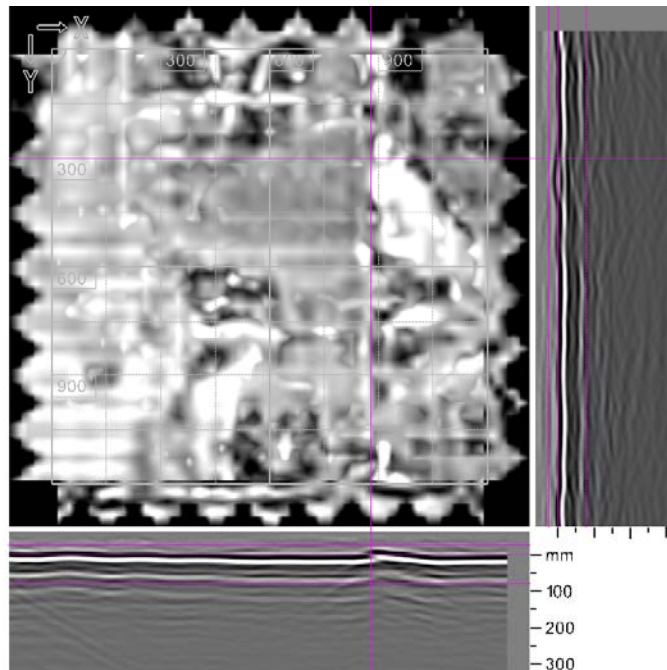
Scan File: RS_316140004_001252
Scan Name: -
Date / Time: 2017-11-28 13:25:04
Comment: -

x: 880 mm
Concrete: 8.8

y: 300 mm

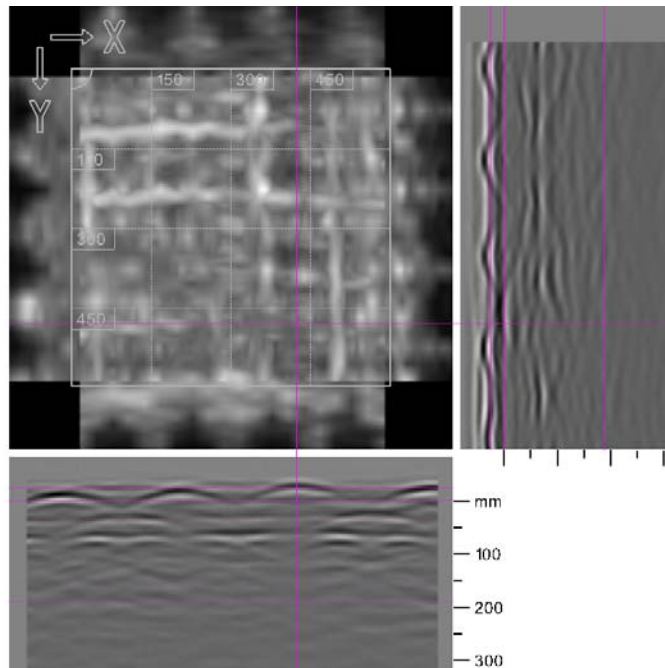
Scan File: RS_316140004_001255
Scan Name: -
Date / Time: 2017-11-28 13:48:23
Comment: -

x: 424 mm
Concrete: 10.0

y: 480 mm

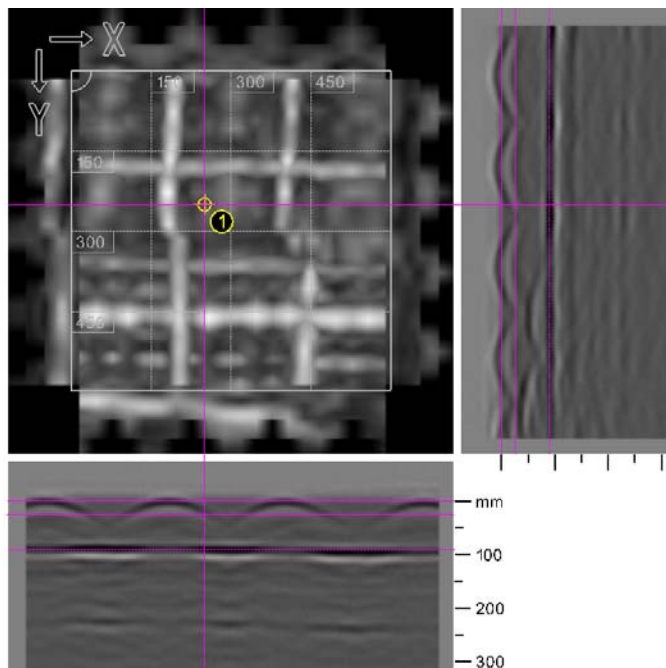
Scan File: RS_316140004_001258
Scan Name: -
Date / Time: 2017-11-28 13:59:40
Comment: -

x: 250 mm
Concrete: 7.0

y: 250 mm

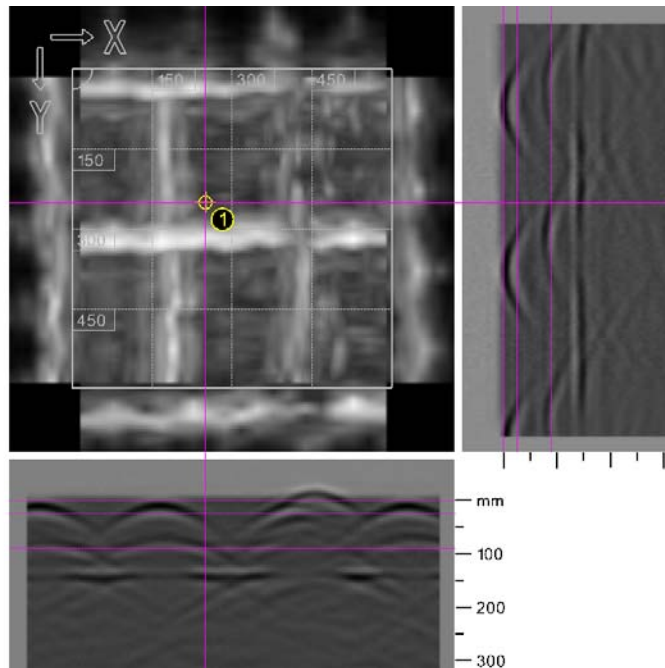
Scan File: RS_316140004_001259
Scan Name: -
Date / Time: 2017-11-28 14:03:04
Comment: -

x: 250 mm
Concrete: 6.5

y: 250 mm

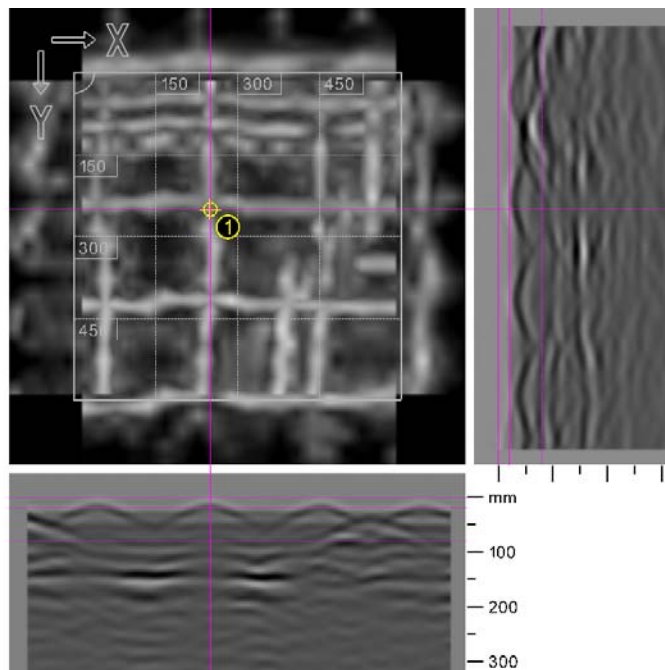
Scan File: RS_316140004_001263
Scan Name: -
Date / Time: 2017-11-28 14:17:41
Comment: -

x: 250 mm
Concrete: 6.5

y: 250 mm

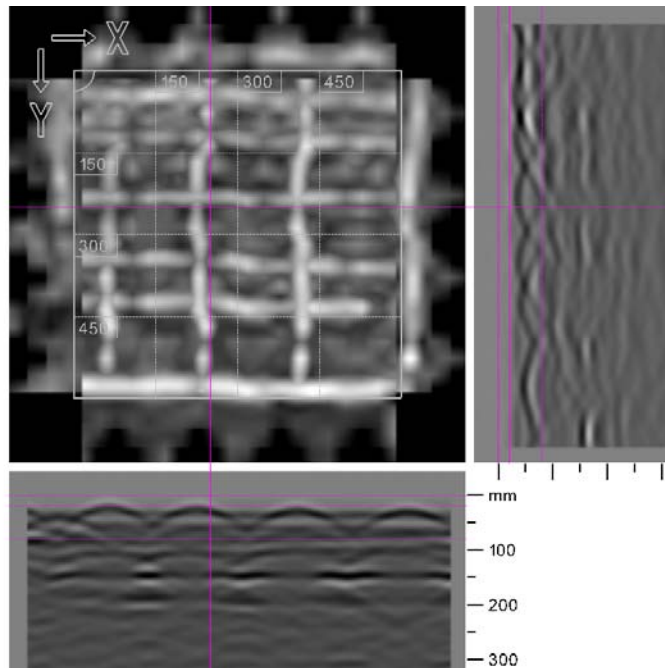
Scan File: RS_316140004_001264
Scan Name: -
Date / Time: 2017-11-28 14:21:29
Comment: -

x: 250 mm
Concrete: 6.5

y: 250 mm

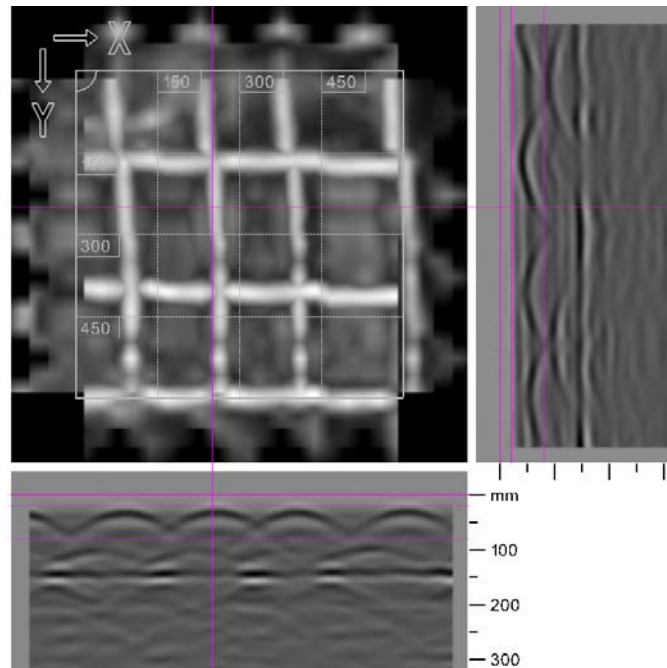
Scan File: RS_316140004_001266
Scan Name: -
Date / Time: 2017-11-28 14:27:40
Comment: -

x: 250 mm
Concrete: 6.5

y: 250 mm

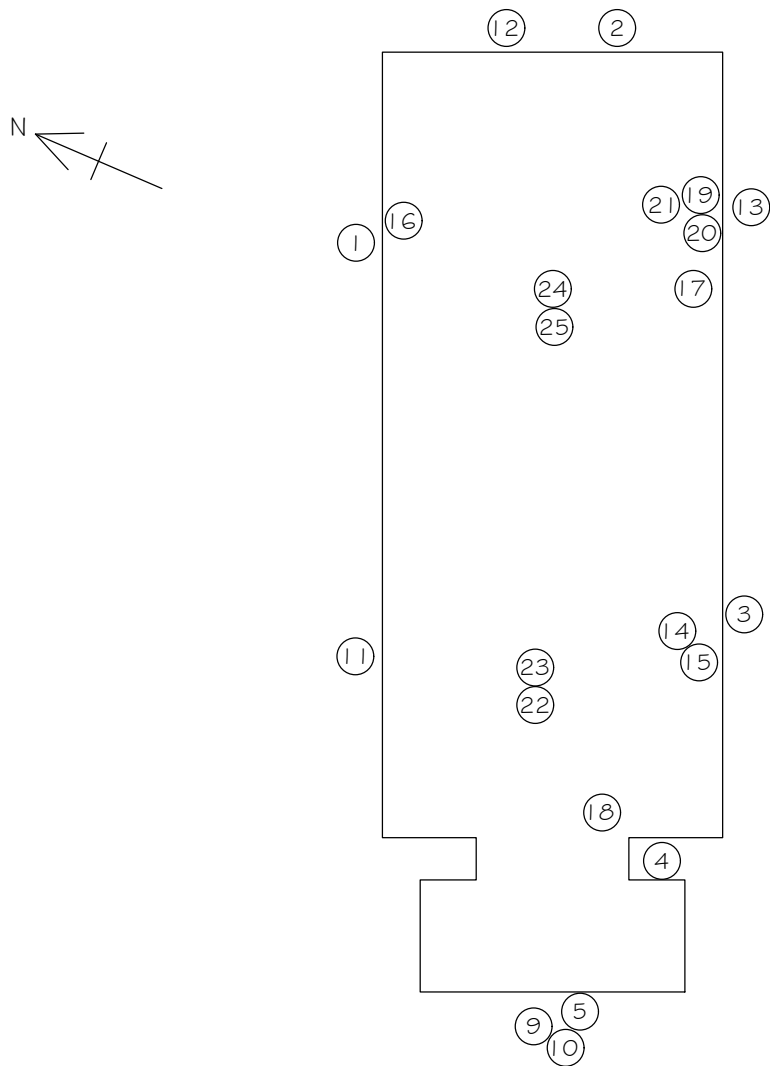
KELSON HOUSE							
Sample ref.	Floor	element	depth profile	cover depth (mm)	carbonation depth (mm)	chloride ion (by mass) presuming 14% OPC (%)	Comments
1	ground	N side wing wall	5 to 25 25 to 50 50 to 75	44	20	0.24 0.11 0.11	timber pattern finish- in-situ
2	ground	E end wall	5 to 25 25 to 50 50 to 75	32	5	0.22 0.09 0.06	timber pattern finish- in-situ
3	ground	S side wing wall	5 to 25 25 to 50	45	20	0.17 0.07	timber pattern finish- in-situ
4	ground	stairwell wall	5 to 25 25 to 50 50 to 75	26	5	0.32 0.15 0.12	paint
5	ground	W end wall	5 to 25 25 to 50 50 to 75	38	5	0.14 0.05 0.02	paint
6	23	stair soffit	5 to 25 25 to 50 50 to 75	22	10	0.09 0.09 0.03	none
7	ground	plant room column	bulk	26	10	0.02	none
8	ground	plant rm slab soffit	bulk	20	5	0.09	low level slab, in-situ
9	1st ext.	W end render	bulk	20	15	0.11	stainless reinforced render on concrete
10	1st ext.	E end wall	bulk	50	10	0.20	shiplap pattern- in situ
