STRUCTURAL CONDITION INSPECTION REPORT
INCORPORATING LIMITED INTRUSIVE INVESTIGATION
AT
KNIGHTHEAD POINT
THE QUARTERDECK
LONDON E14 8SR

Project Number	6627
Document Ref:	D008-A
Revision	A
Prepared by	I D Isherwood
Date prepared	24 January 2018
Client

Report Following Concrete Testing

Knighthood Point
The Quarterdeck
London
E14 8SR

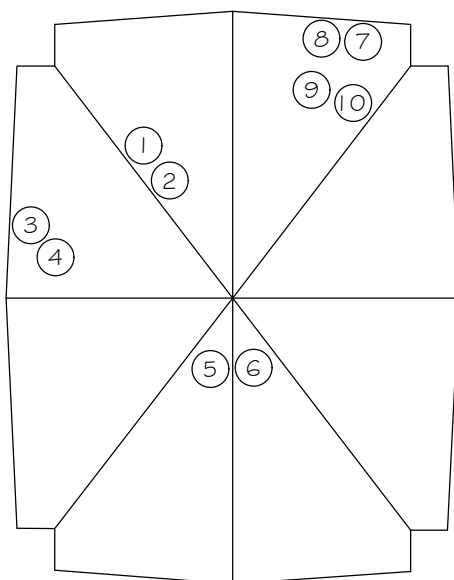
KNIGHTHEAD POINT							
Sample	Floor	element	depth	cover	carbonation	chloride Ion (by mass)	Comments
ref.			profile	depth	depth	presuming 14% OPC	
				(mm)	(mm)	(%)	
1	roof	lift motor room wall	bulk	60	5	0.07	previous surface removal, In-situ
2	roof	lift motor room slab	bulk	40	5	0.10	covered by metal framed roof, In-situ
3	20	stair soffit	bulk	18	5	0.03	painted
4	20	stair wall	bulk	30	5	0.04	painted
5	ground	tank room wall	bulk	36	5	0.02	1/2 basement level
6	ground	tank room soffit	bulk	20	5	0.03	1/2 basement level
7	ground	plant room column	bulk	60	5	0.04	exposed
8	ground	plant room end wall	bulk	37	5	0.03	end wall clad externally in brickwork
9	ground	plant room pier	bulk	60	5	0.02	exposed
10	ground	plant room beam	bulk	35	10	0.10	exposed
