STRUCTURAL CONDITION INSPECTION REPORT
INCORPORATING LIMITED INTRUSIVE INVESTIGATION
AT
MIDSHIP POINT
THE QUARTERDECK
LONDON E14 8SW

Project Number	6627
Document Ref:	D009-A
Revision	A
Prepared by	I D Isherwood
Date prepared	24 January 2018
Client

Report Following Concrete Testing

Midship Point
The Quarterdeck
London
E14 8SW

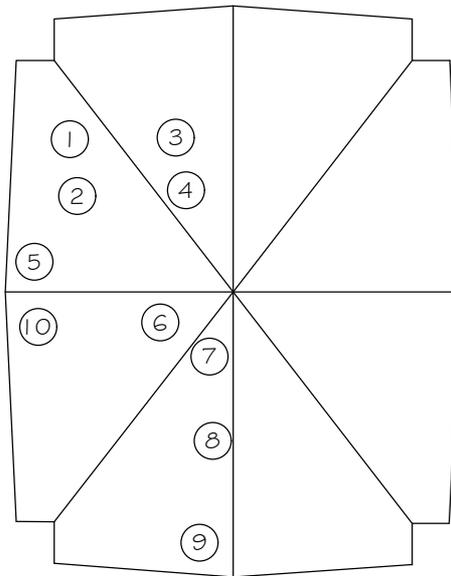
MIDSHIP POINT							
Sample	Floor	element	depth	cover	carbonation	chloride Ion (by mass)	Comments
ref.			profile	depth	depth	presuming 14% OPC	
			(mm)	(mm)	(mm)	(%)	
1	12	internal wall	bulk	25	3	0.09	exposed
2	12	slab soffit	bulk	19	3	0.02	exposed. In-situ
3	roof	lift motor room wall	bulk	50	5	0.05	adjacent previous render removal
4	roof	tank room slab	bulk	40	5	0.10	exposed. In-situ
5	20	stair soffit	bulk	21	3	0.06	painted
6	ground	electric Intake wall	bulk	35	3	0.03	exposed. In-situ
7	ground	tank room slab soffit	bulk	12	3	0.09	exposed. in-situ
8	ground	tank room wall	bulk	50	5	0.05	exposed
9	ground	tank room outer wall	bulk	42	3	0.05	outer wall. Minor cracking. Covered by canopy
10	ground	entrance wall	bulk	50	4	0.40	by door. covered by canopy
