Condition Report of the Building Services Installation.

Kelson House

Prepared by MCCE on behalf of Hunter & Partners for One Housing

February 2018

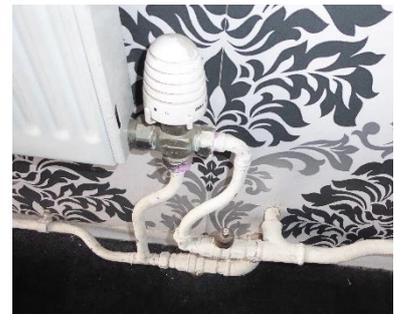
Radiator valve and
pipework into adjacent
dwelling through wall.

Any changes to radiators or hot water cylinder within the dwellings will have an effect on the system within the entire block as there is no separation in the system.

Individual radiators cannot easily be isolated past the radiator valve which makes modify the size or relocating a radiator a specialist job which may require access to an adjacent dwelling.

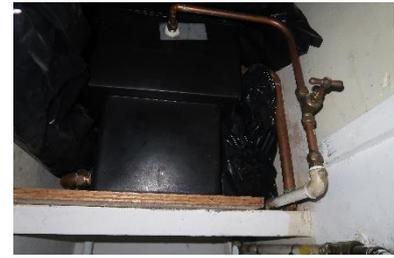
Cold Feed
Tank in Flat 16

The cold feed tanks had been replaced in one of the dwellings inspected with an original galvanised steel tank in the other unit.

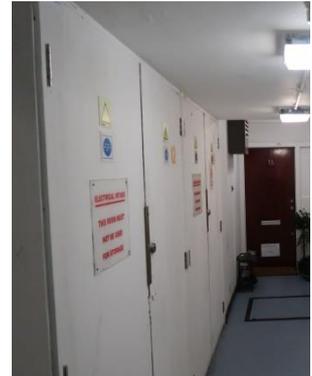
The incoming supply enters the building at the ground floor intake room access from the corridor off the main entrance lobby. Access was not gained to this area.

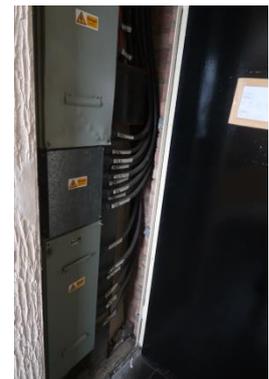
From the main intake room the rising bus bars are fed. These rise through the building in the service risers and have tap offs periodically to serve the dwellings on alternate levels.

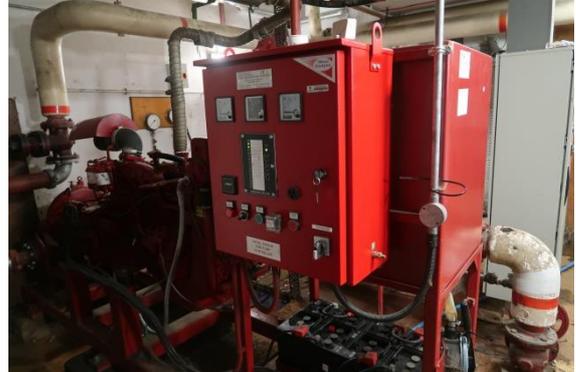
The pump and tanks are located with the Cold water storage tanks in the ground floor plant room.

The pump has a diesel generator and serves landing valves on each floor of the building.
